HENDERSON HOUSE

HISTORIC STRUCTURES REPORT

Published: May 6, 2014.

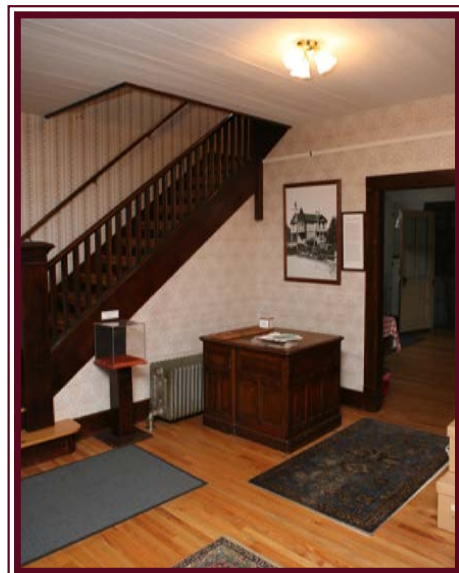
- Overall good condition but with a few issues, including:
- 1-inch gap between baseboard and wall in northeast corner
- Baseboard pulling away from wall behind radiator on north wall

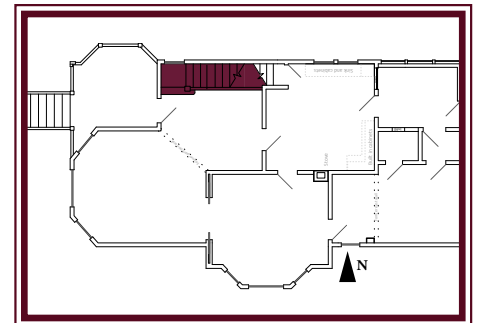
- Split and damaged baseboard

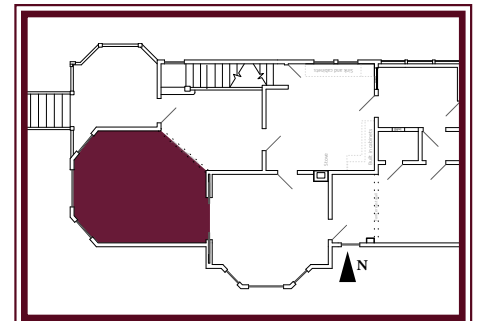
- Overall good condition but with a few issues, including:
- A couple holes in windows
- Minor damage to window sashes
- Chatter marks on casings
- Baseboard pulling away from west wall, behind the radiator

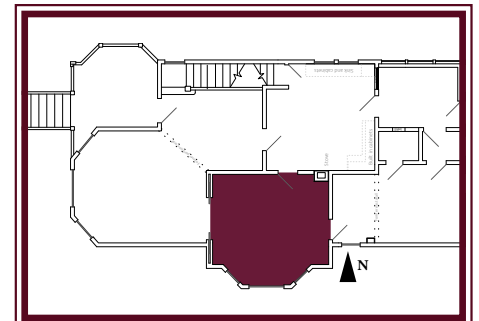
- Baseboards pulling away from each other at southeast corner of bay window
- Base block in northwest corner pulling away from wall
- Apron below center bay window discolored behind radiator
- Portions of wallpaper discolored and cracked
- Chimney chase still used as ventilation as wall is warm to the touch

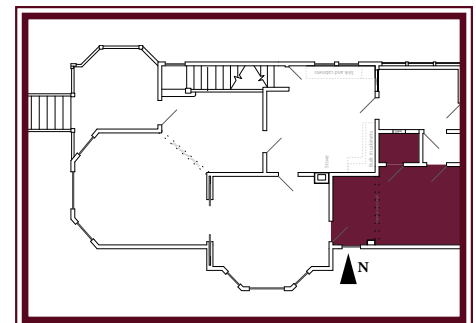
- Baseboard on west wall bowing out away from wall
- Section of baseboard cut beneath window on south wall
- Cracked glass and holes in east window glazing
- Cracked wallpaper

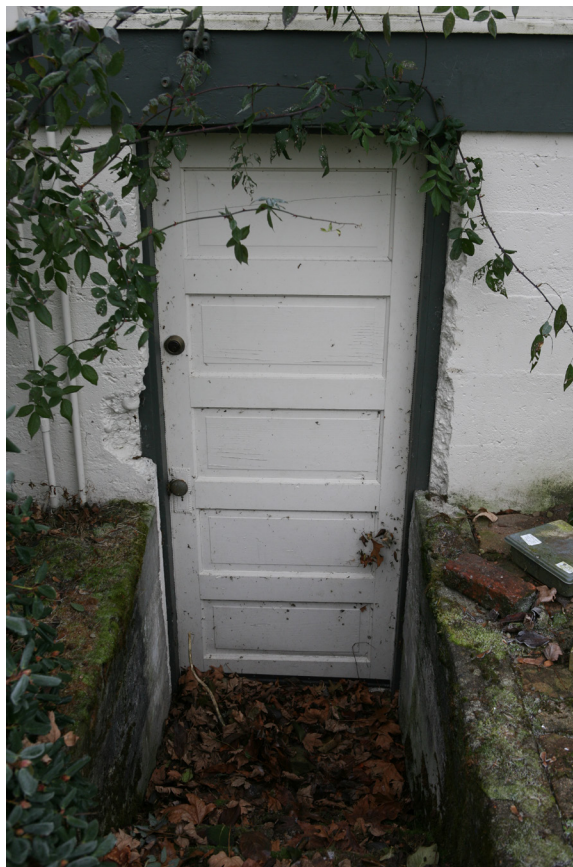
CP 34. View of basement door, north facade. Leaf debris collecting at landing. Source: Artifacts Consulting, Inc.

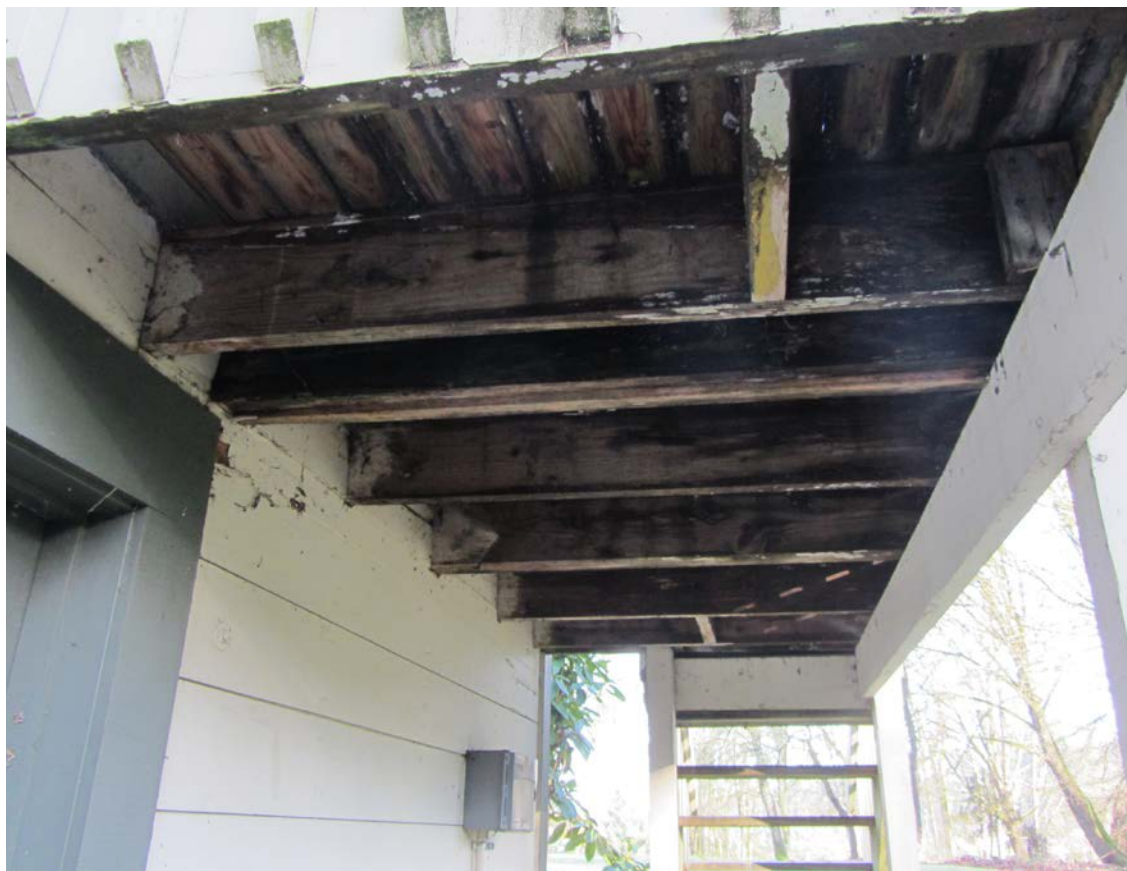
CP 33. Rear porch detail. Paint deterioration along the rear facade. Source: Artifacts Consulting, Inc.

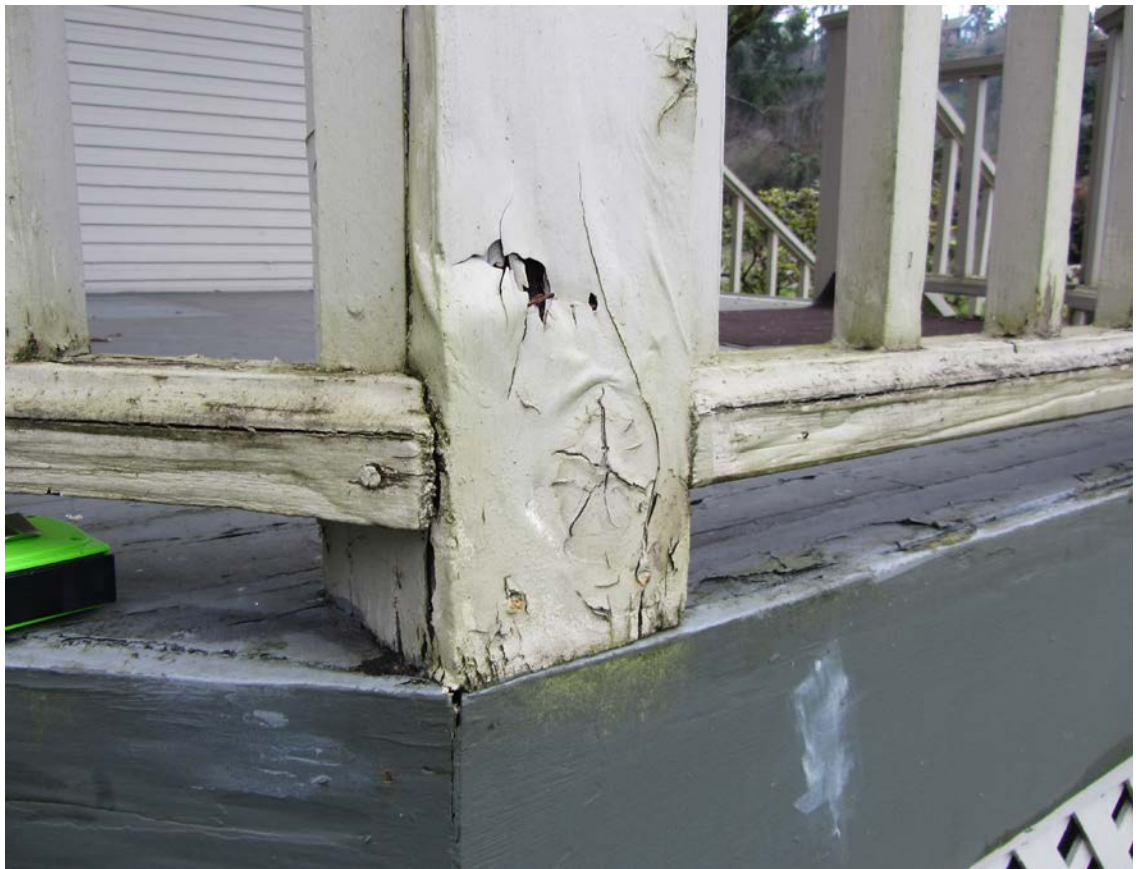
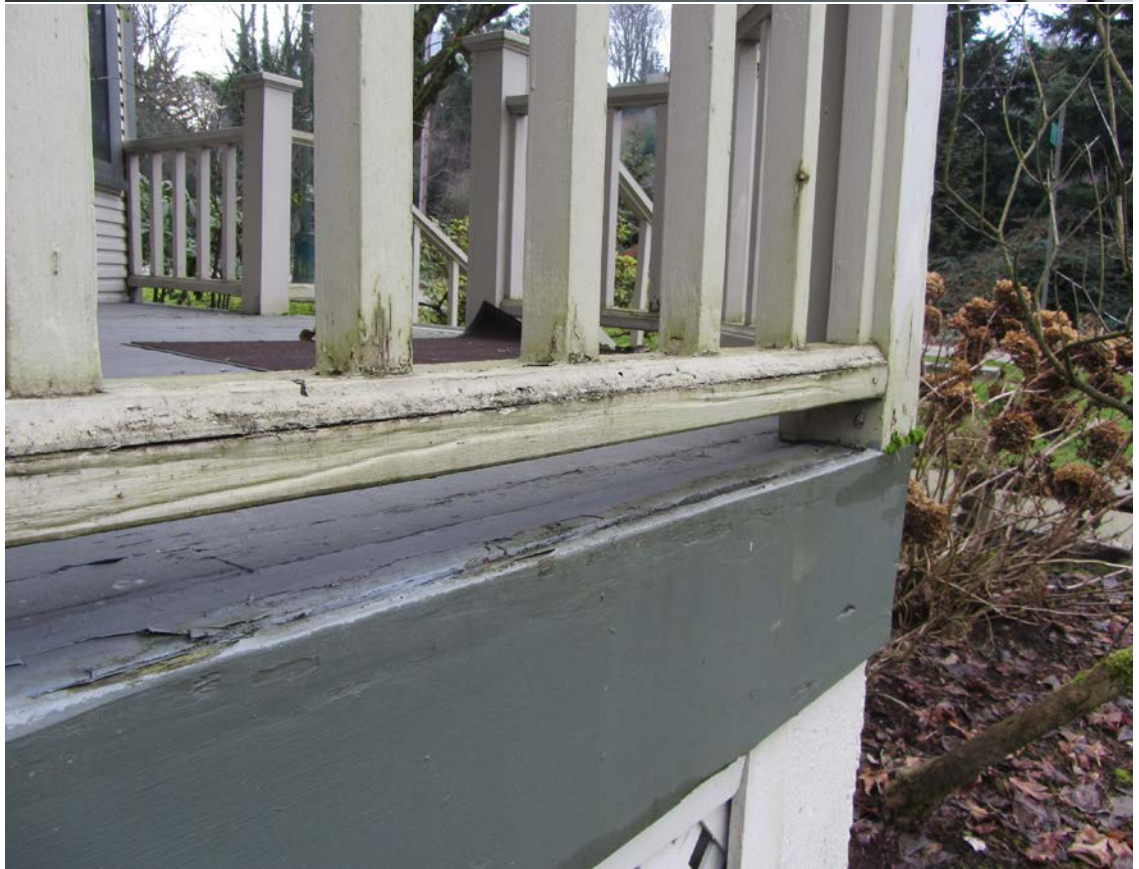
CP 36. Detail of front porch condition issues. Source: Artifacts Consulting, Inc.

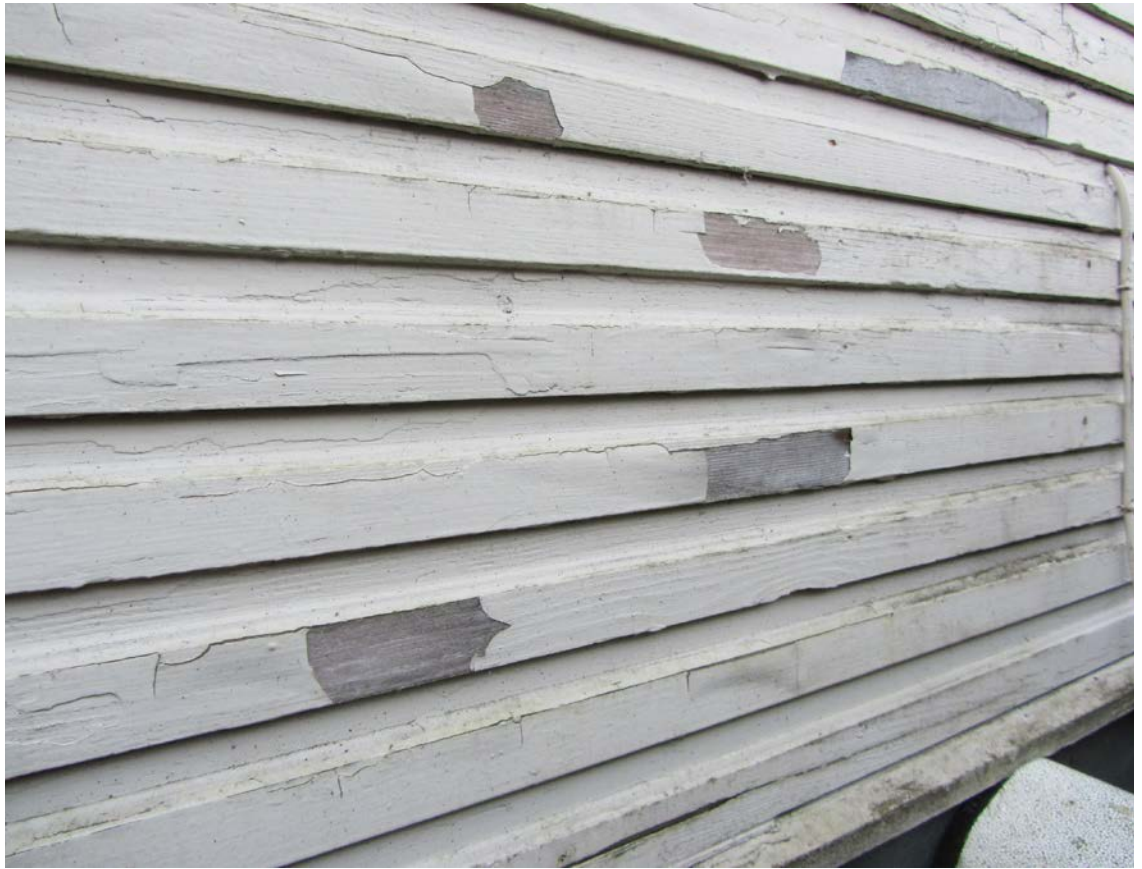
CP 37. Deteriorated paint. Source: Artifacts Consulting, Inc.

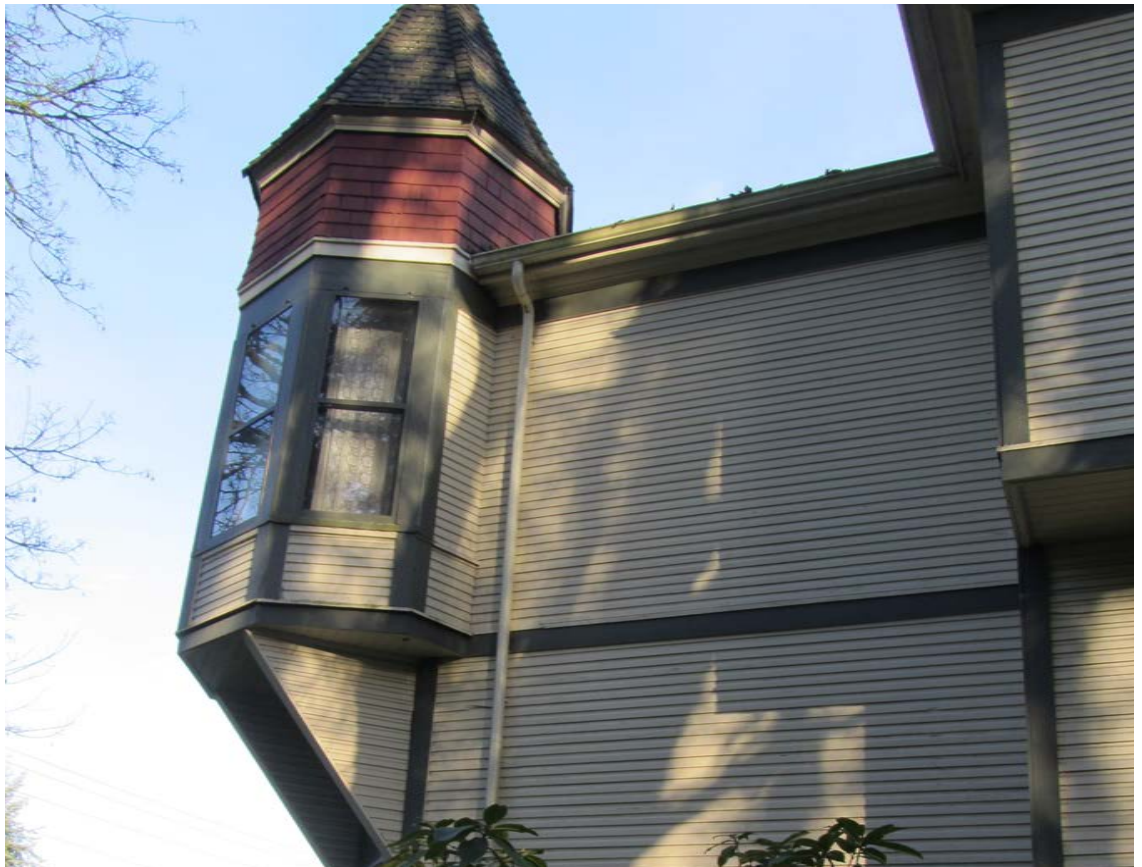
CP 38. Leaf debris collecting in gutter. Source: Artifacts Consulting, Inc.

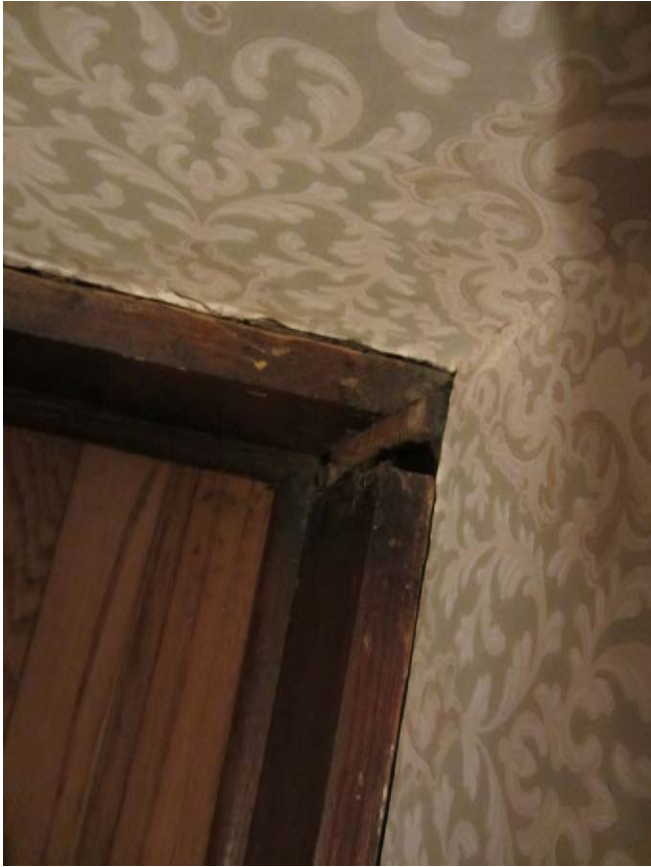
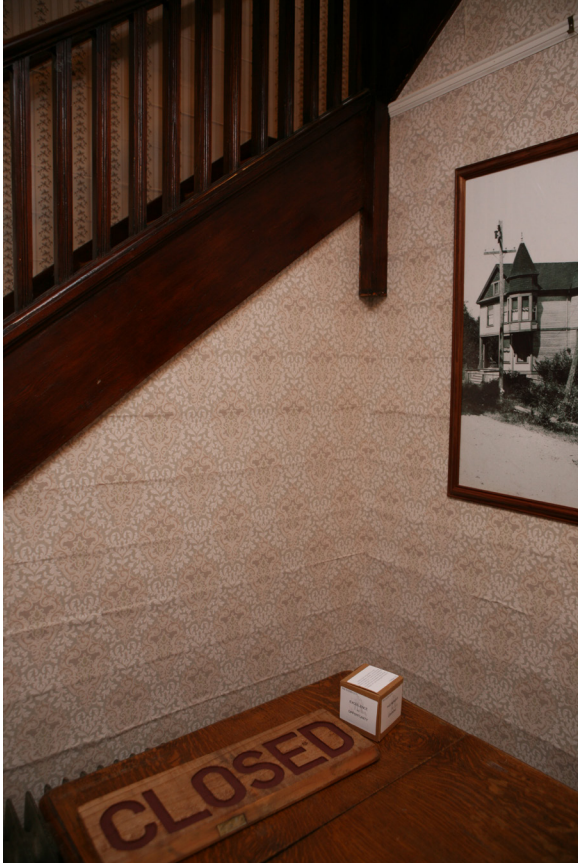
CP 40. Missing end piece on stair newel. Source: Artifacts Consulting, Inc. CP 39. Baseboard detail, missing corner piece. Source: Artifacts Consulting, Inc.
