Mukai

Farmstead and Garden

PRESERVATION PLAN

April 2017

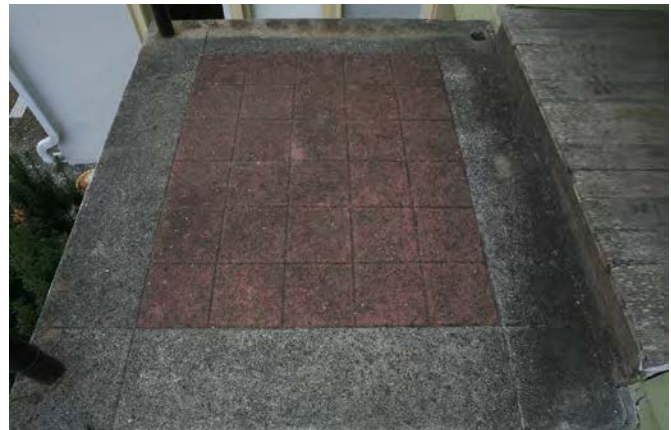
Entrance, West, First Floor

- Added concrete at threshold to build up due to settlement
- New metal threshold
- Glazing putty added at some missing stop locations on door

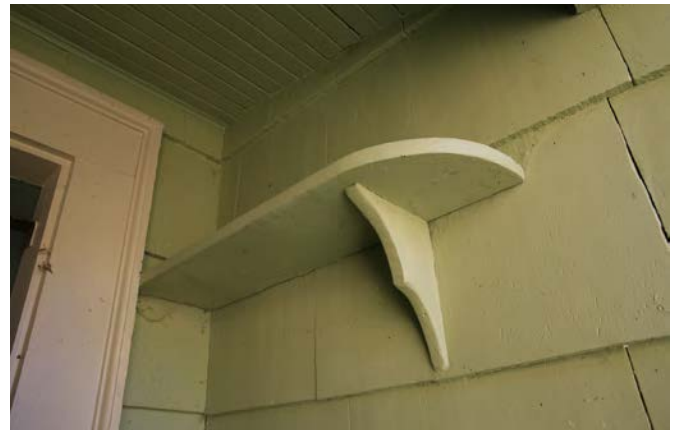
Entrance, East

- New dead bolt at door
- Added rubber walk off mat at exterior
- New weather stripping along bottom rail
- Replacement wood threshold

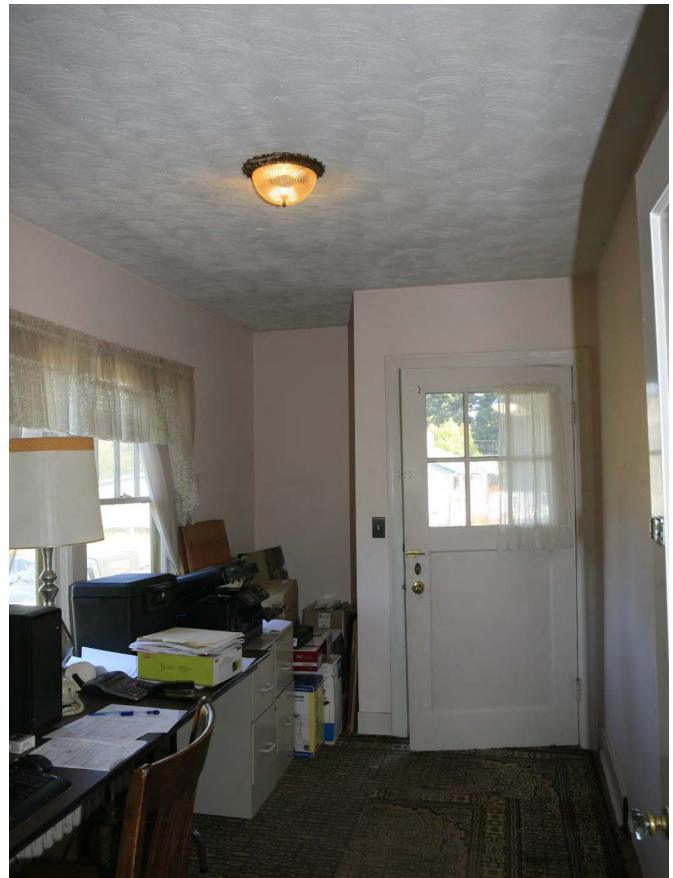
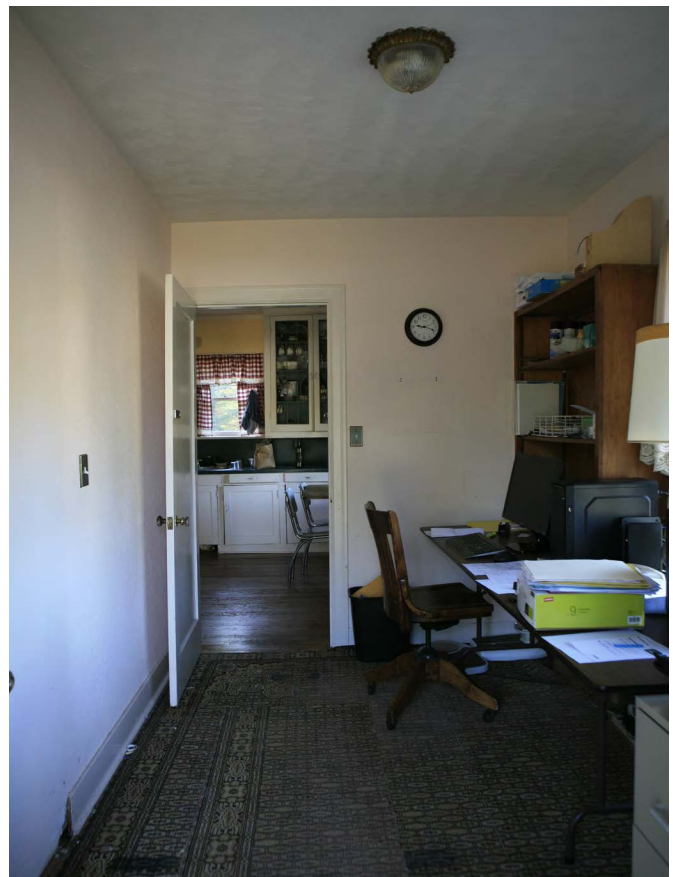
Hallway

- Added scalloped finish at ceiling. The north portion of the ceiling was also replaced with sheet rock due to water damage. Some of the original lath and plaster remains at the south end. R19 fiberglass insulation installed above a portion of the ceiling.
- Contemporary ceiling light fixture.
- Sheet rock installed on the south, west, and north walls over the lath and plaster and at the infilled doorway on the east wall.

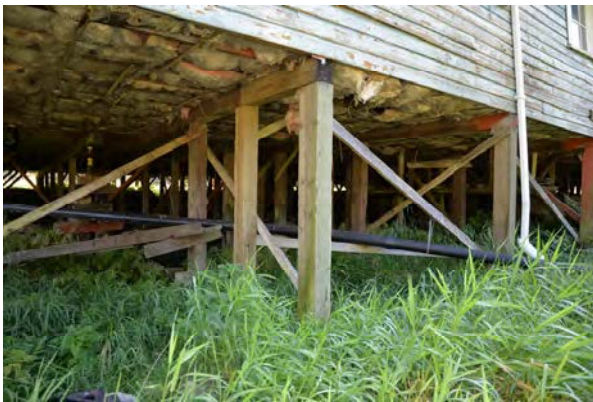
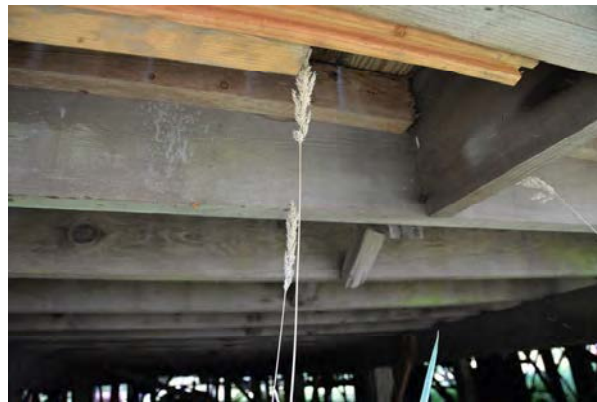
Foundation, Pier Structure & Floor Structure

The original building was constructed in the 1920s, and includes the original rectangular structure, an addition on the west side, and an addition on the north side. The original building consisted of a 3,259 SF interior space and a 1,530.5 SF loading dock on the east side. A 1,530.5 SF addition was built on the west side, and a 507.5 SF addition was built on the north side. At the time of this report, we do not have the exact dates that the additions were built, however, the 1933 aerial photo shows just the barreling plant and loading dock, and the 1959 aerial photo shows the original structure with both north and west additions. The total footprint of the structure is approximately 6,827.5 SF. Access to the building is from a stair to the loading dock on the east side. There are several doors and barn doors on the east side for entry and access. There is a single door on the west side of the structure, with a dilapidated stair leading up from the ground below.
