HENDERSON HOUSE

HISTORIC STRUCTURES REPORT

Published: May 6, 2014.

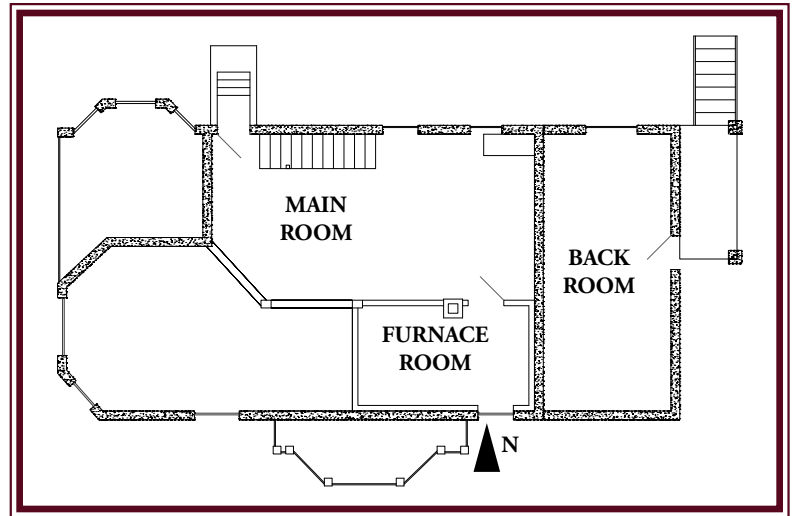
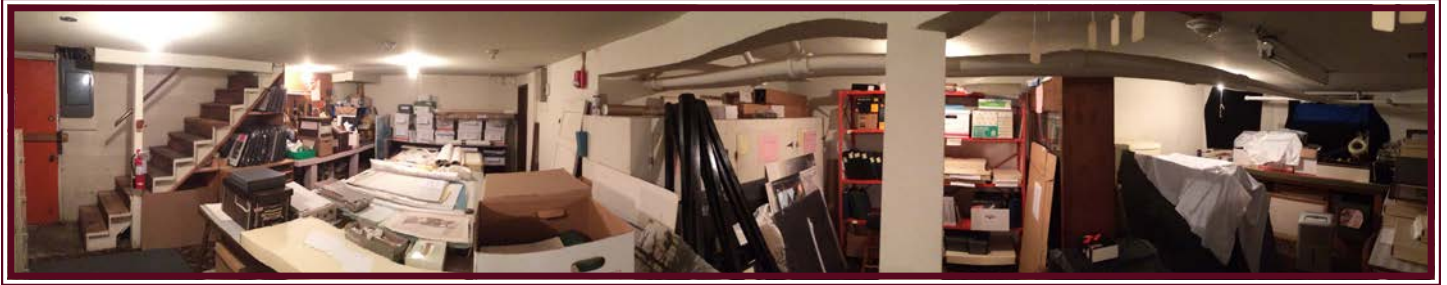
MAIN ROOM

The main room in the basement is irregularly shaped, bounded by the board formed concrete foundation walls. Finished wall surfaces feature painted sheet rock. A stairwell leading upstairs to the kitchen runs along the north wall of the room. A door, at the base of the stairs, leads outside. A work bench runs along the eastern end of the north wall, beneath the stairs.

- Overall good condition

- Sheet rock and stud framing installed over perimeter walls to increase insulation
- Windows on north facade boarded over and former door or window boarded over with plywood
- Carpeting over concrete floor
- Multiple built in and free standing storage and work furnishings throughout the space related to museum operations
- Stairs down from the first floor
- Added wiring, lighting, and fire detection systems
- Dehumidifier in space for collections curation
- Added wood security bar on door
- Former coal chute and other windows covered up or not invisible from the interior
- Added door to boiler room

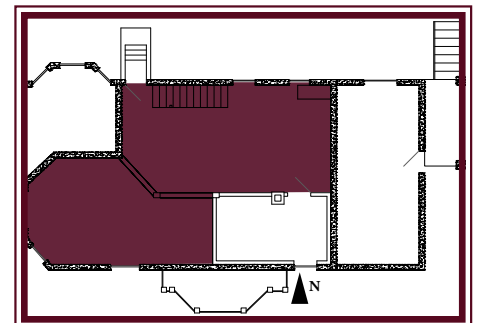
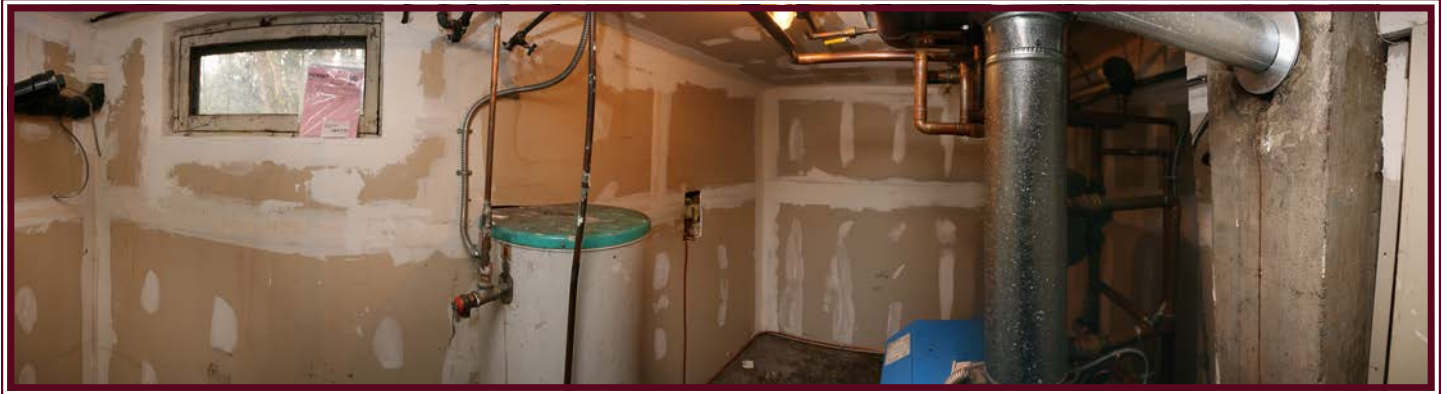
FURNACE ROOM

The basement furnace room is located in the southeast corner of the basement and is accessed from the main basement room. A small window in the south wall provides daylight to the interior. The building's furnace and hot water heater are both located in this room.

- Overall good condition

- Installed sheetrock and stud walls around space to increase insulation and create temperature separation from adjacent storage space used for museum collections storage
- New boiler installed

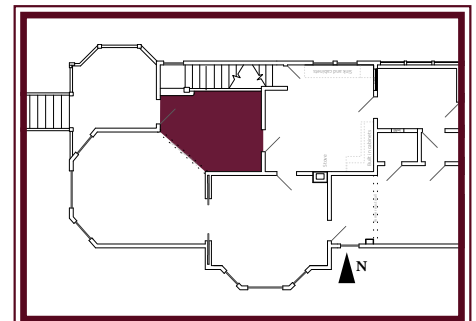
- Overall good condition but with a few issues, including:
- 1-inch gap between baseboard and wall in northeast corner
- Baseboard pulling away from wall behind radiator on north wall

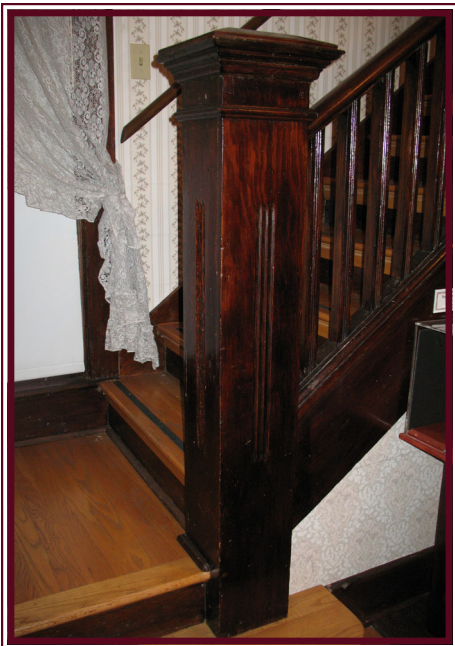
- Split and damaged baseboard

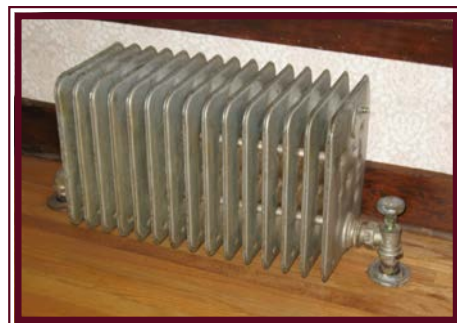
- Overall good condition but with a few issues, including:
- A couple holes in windows
- Minor damage to window sashes
- Chatter marks on casings
- Baseboard pulling away from west wall, behind the radiator

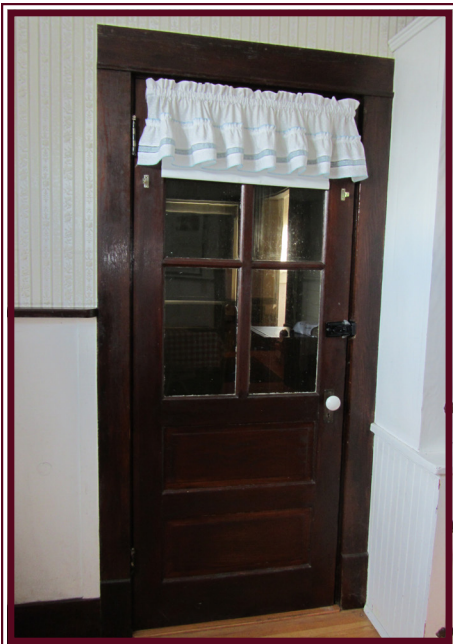
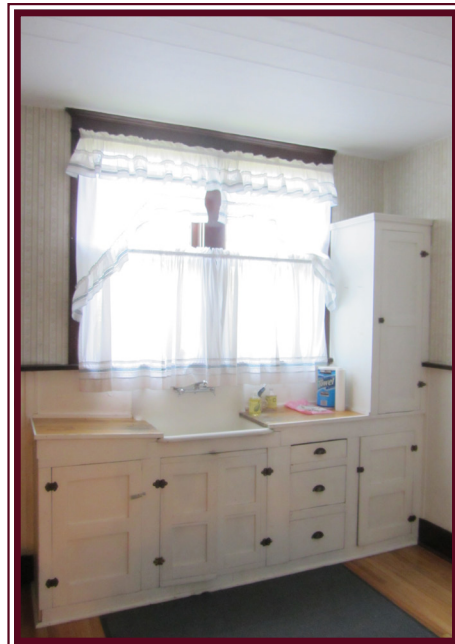
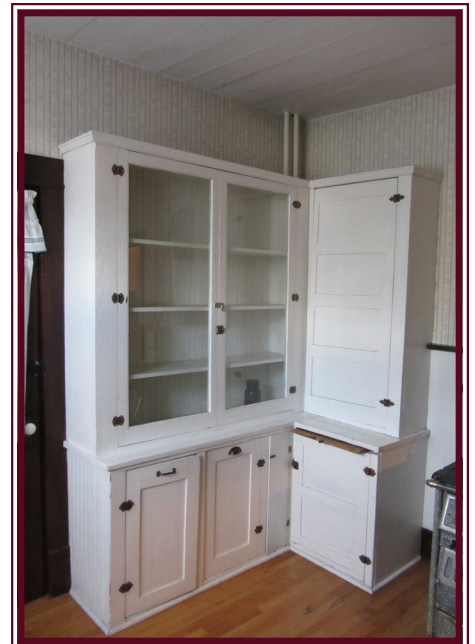
- General wear and tear

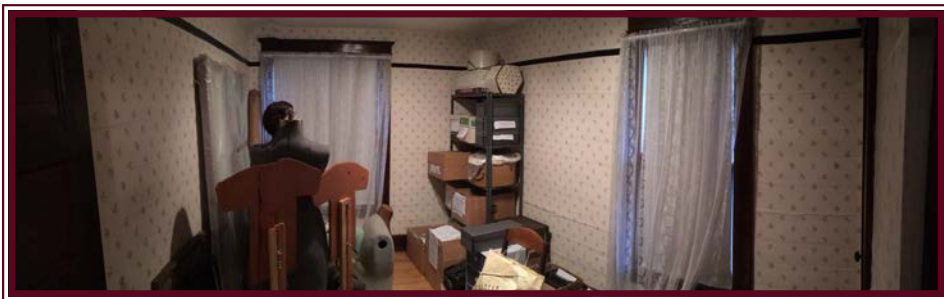
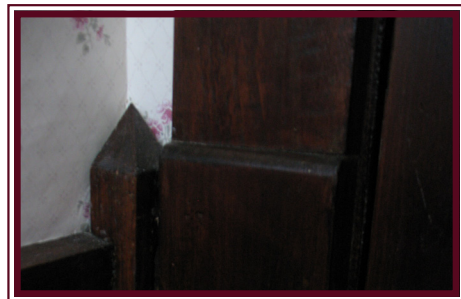
Condition:

- Overall good condition. Cosmetic crack in stool of west window and cosmetic split in baseboard behind door, likely from when the flooring was redone.

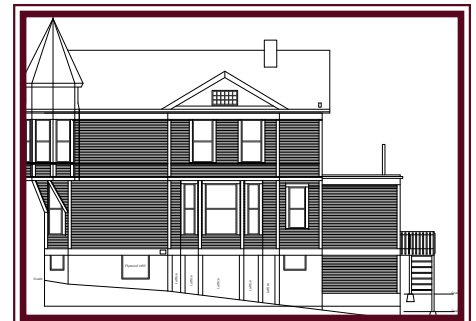
Condition:

- Good condition overall
- Paint failing along portions of the facade
- Some deteriorated wood and failed paint along the bottom of the lattice at the bay window
- Deteriorated wood and failed paint at the base of the posts at the front porch; this occurs most prominently at the outer west post having the greatest exposure to the elements
- Some damaged concrete edges along the window openings and a thin (< 1/16 inch wide) crack off the lower east corner of the plywood in filled basement window.

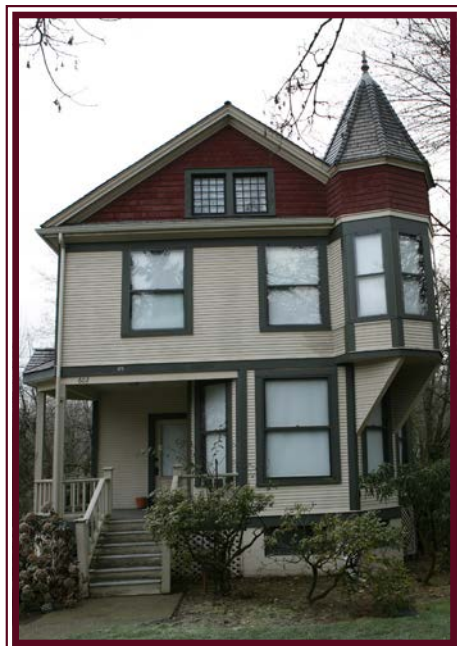
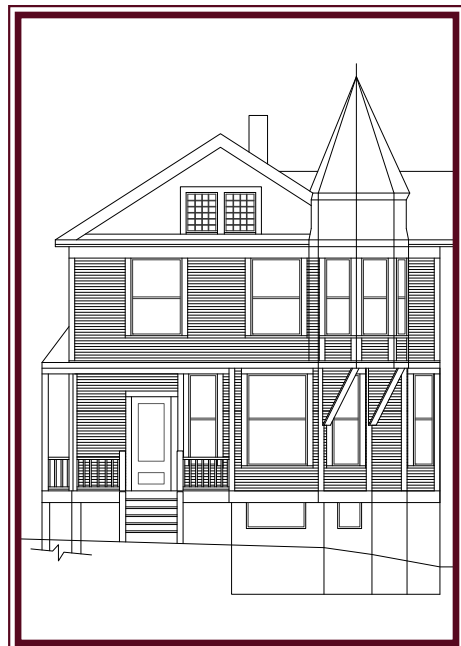
Condition:

- Good condition overall
- Paint failing along portions of the facade
- Some deteriorated wood and failed paint along the bottom of the lattice at the bay window
- Deteriorated wood and failed paint at the base of the posts at the front porch; this occurs most prominently at the outer west post having the greatest exposure to the elements
- Some damaged concrete edges along the window openings and a thin (< 1/16 inch wide) crack off the lower east corner of the plywood in filled basement window.

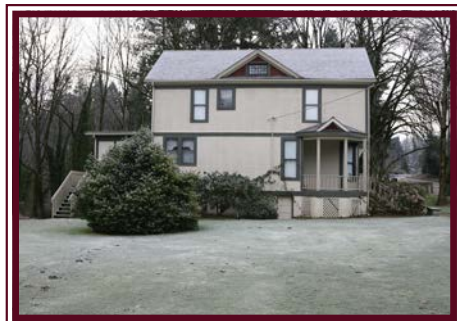
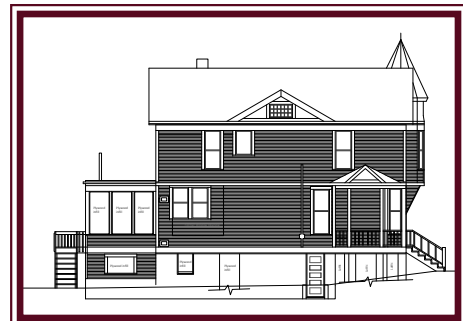
Condition:

- Good condition overall
- Paint failing along portions of the facade, particularly below the kitchen windows
- Deteriorated wood and failed paint along the bottom of the lattice at the porch; some portions of the lattice had been in contact with the ground, accelerating their deterioration
- Deteriorated wood and failed paint at the base of the posts at the front porch; this occurs most prominently at the outer west post having the greatest exposure to the elements
- Previous damage at concrete foundation around door and window openings, consisting of broken off sections

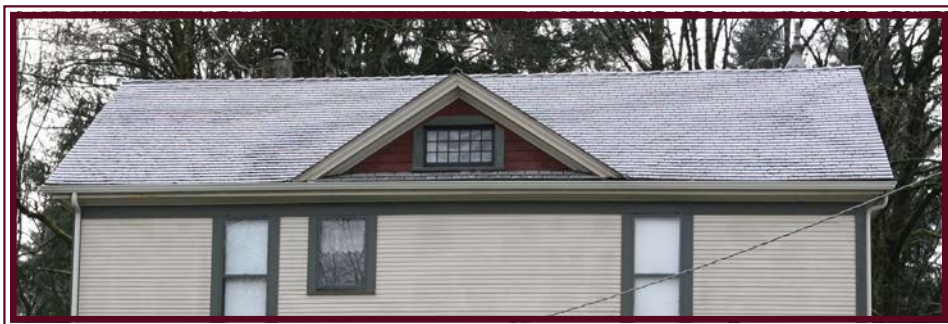
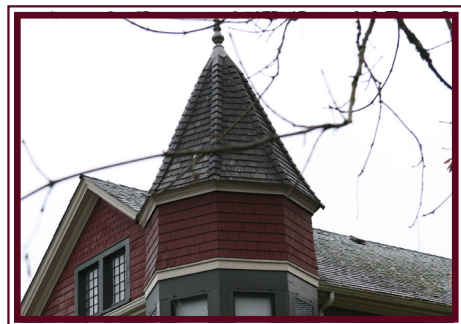
Condition:

- Good condition overall
- Gutters on the south facade are filled with debris from the adjacent trees
