Mukai

Farmstead and Garden

PRESERVATION PLAN

April 2017

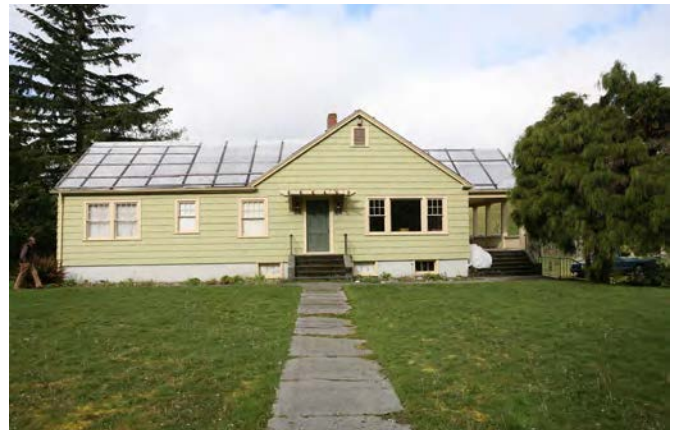
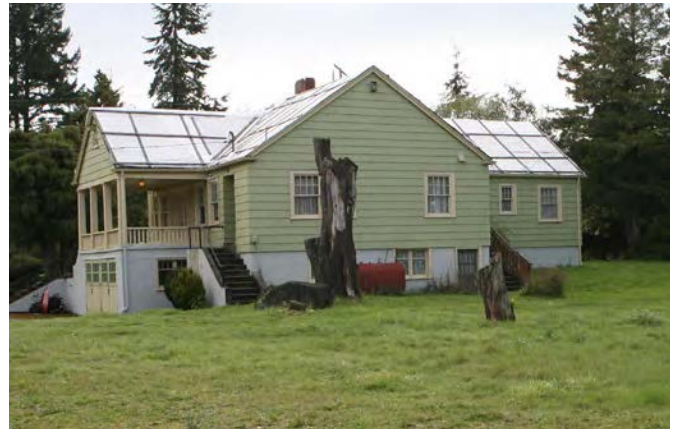
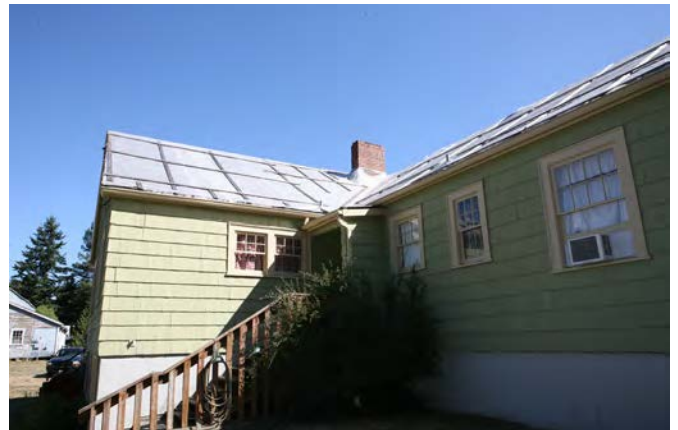
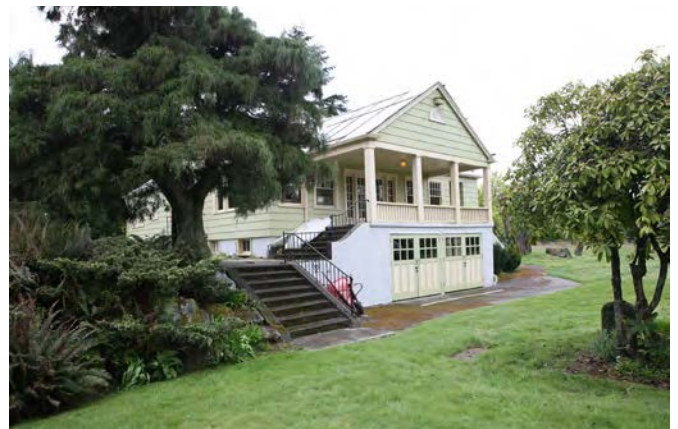
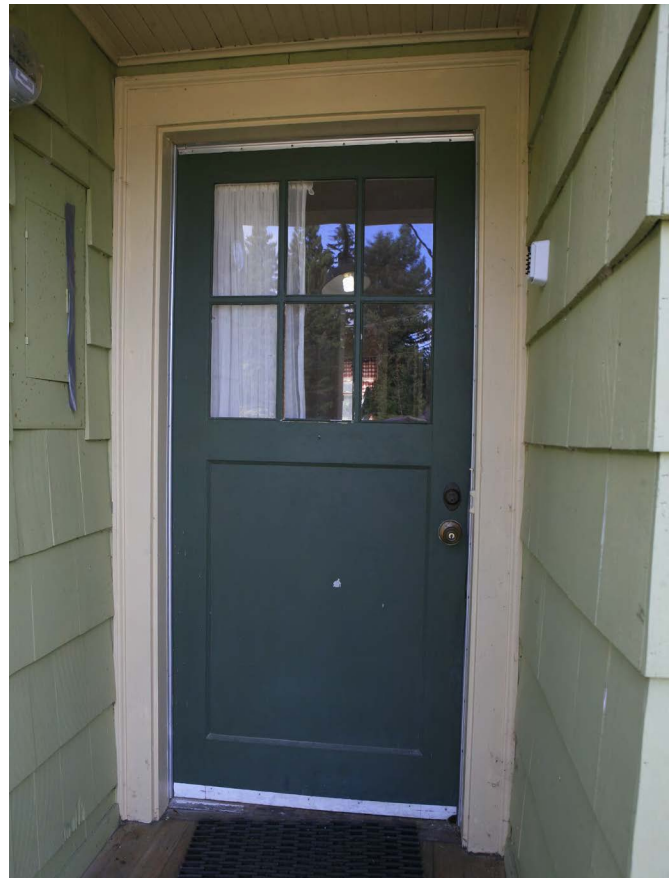
Entrance, Northwest, First Floor

- Metal post adjacent house at landing removed and new connection installed linking the railing to the house.
- Contemporary knob, round escutcheon
- Electrical panel added within alcove along north side (original connection occurred at west gable end)
- Added rubber walk off mat at exterior
- Pressure treated riser at the transition from the concrete landing up to the inner wood landing, along with metal flashing
- Added ½" by 3" boards along sides of inner landing at transition to shingles
- Stairs settled 1 to 2 inches
- Weather stripping added at door, in poor condition

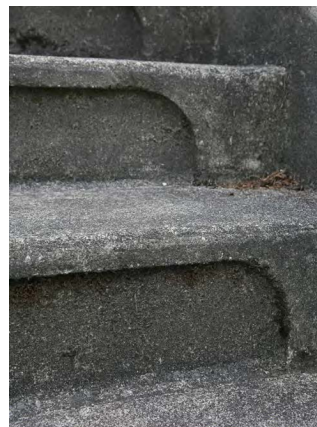
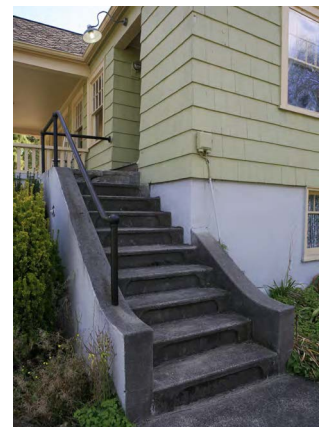
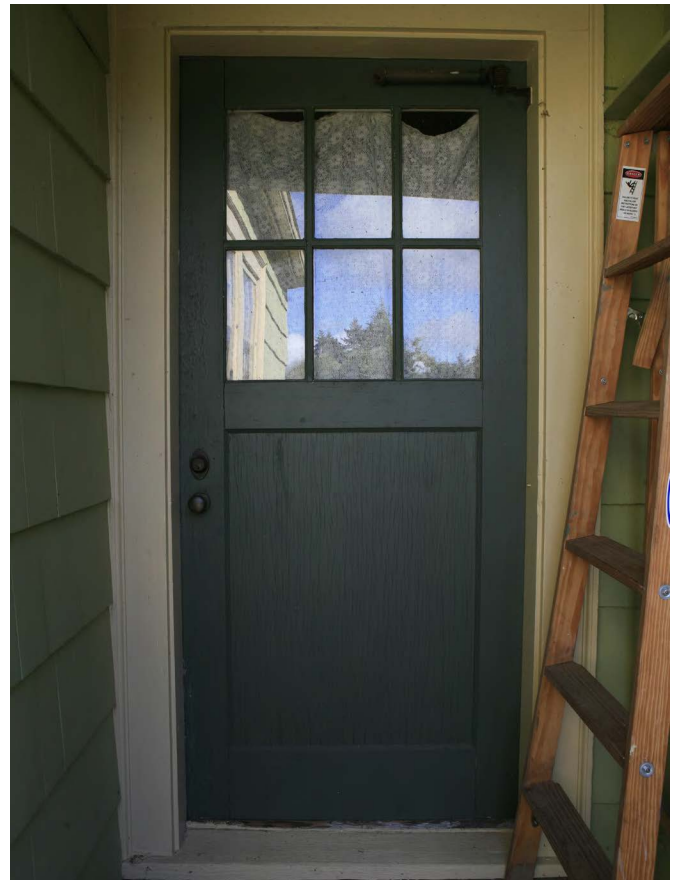
Entrance, West, First Floor

- New throw bolt on interior
- Pressure treated wood steps, railing, and landing leading up from lower concrete steps to entrance
- Curtains added at interior

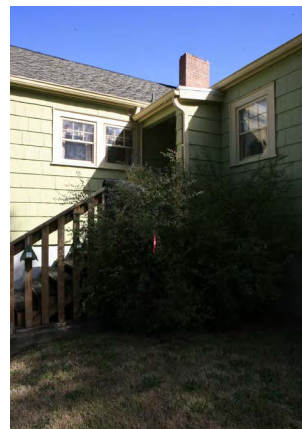
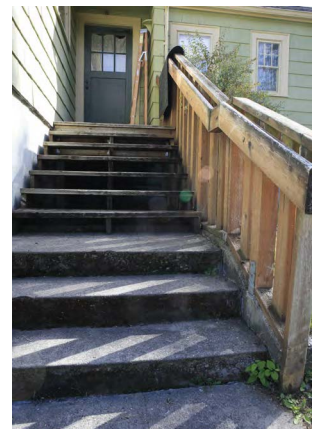
Entrance, West, Basement

- Added concrete at threshold to build up due to settlement
- New metal threshold
- Glazing putty added at some missing stop locations on door

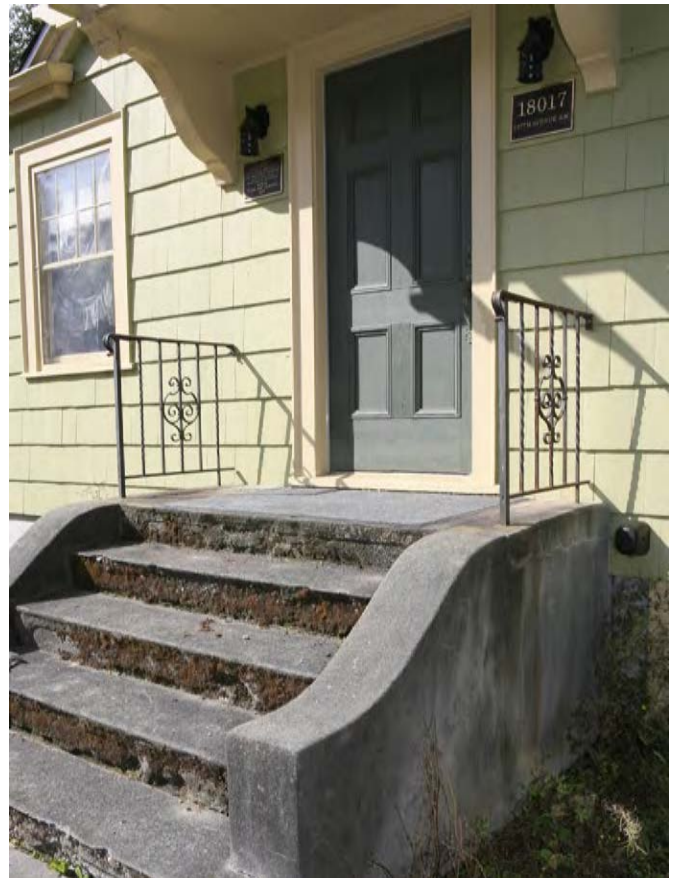
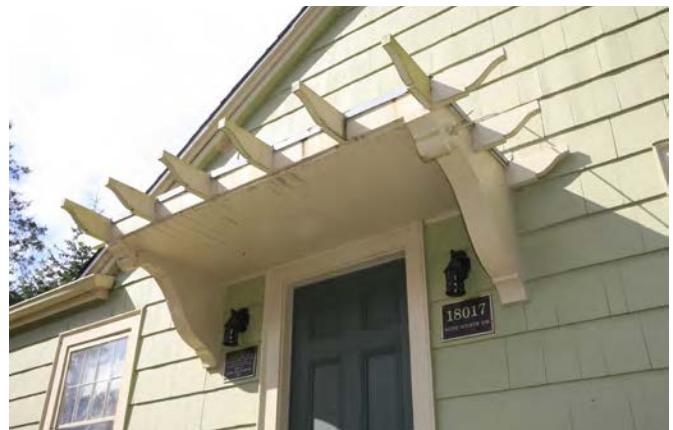
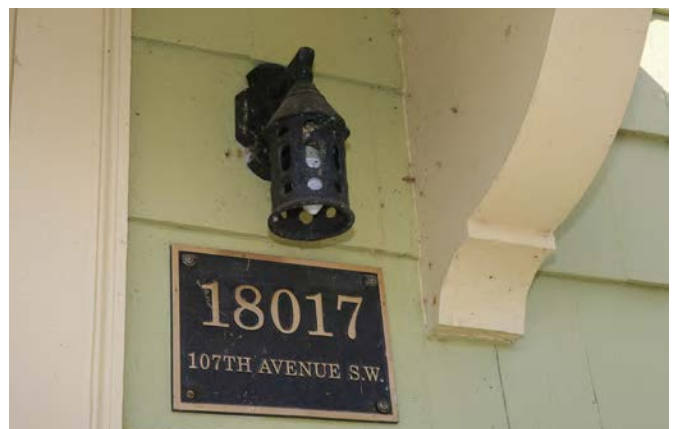
Entrance, East

- New dead bolt at door
- Added rubber walk off mat at exterior
- New weather stripping along bottom rail
- Replacement wood threshold

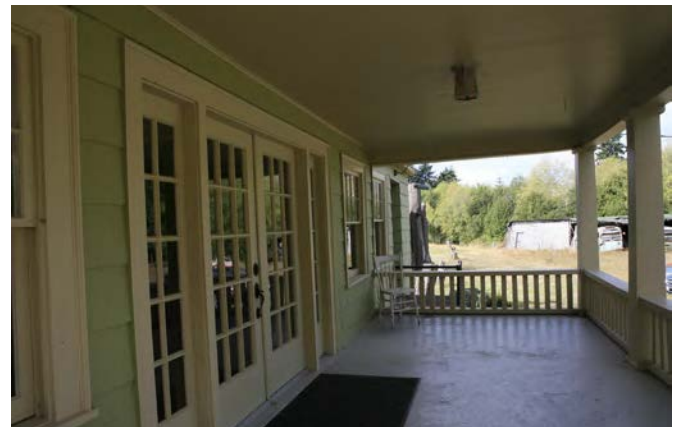
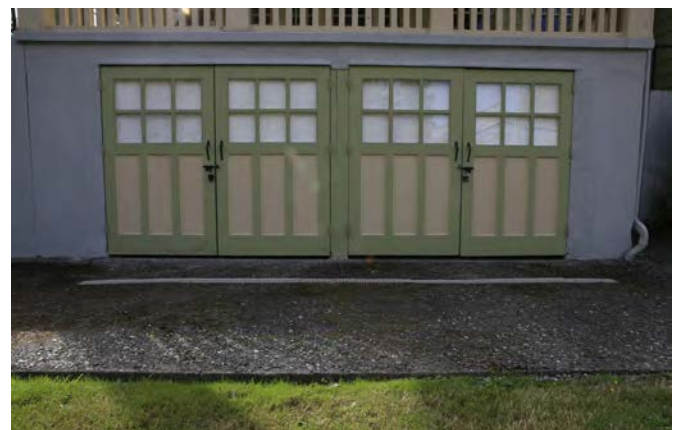
Entrances, North, Porch & Garage

- Electrical outlet added immediately east of the entrance door sidelight
- Exterior light switch east of the main north entrance, unknown what light this switch connects to
- Replacement parging along the north and west sides of the garage walls
- Added painted coating on the concrete porch slab
- Added wood post between the garage doors supporting the header
- Garage doors rebuilt, 6 lite with 3 lower panels, two sets of paired doors, side hinged, wood.
- Previous crack patching along the length of the west facade above the window header height and along the north side above the garage doors
- New concrete apron along north side of the doors with an added drain

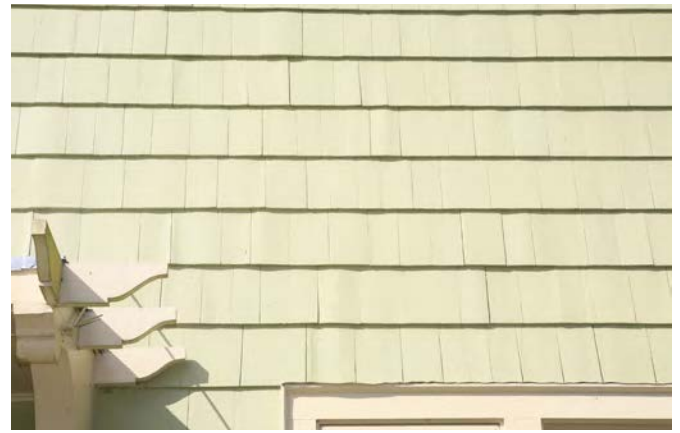
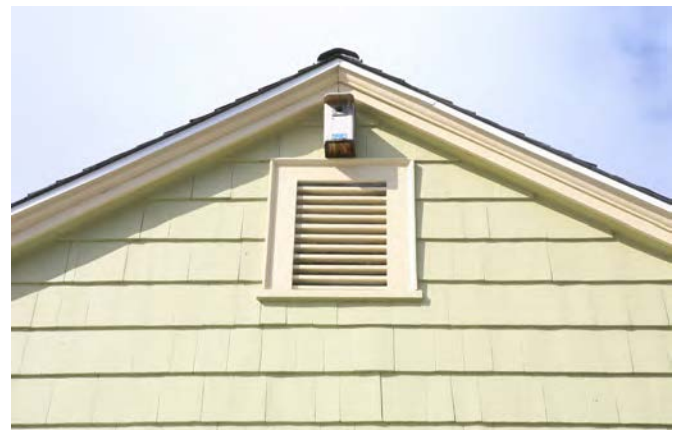
Siding

- Added wood bird house in the east gable end
- Added Ethernet cable connection run through siding to exterior at southeast corner of house, opening is sealed, functional but not the best way to do this.
- Phone and cable internet connection, line and box on north end of west facade

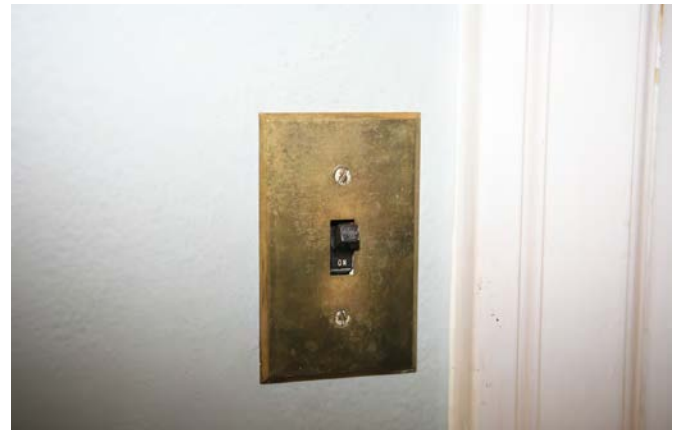
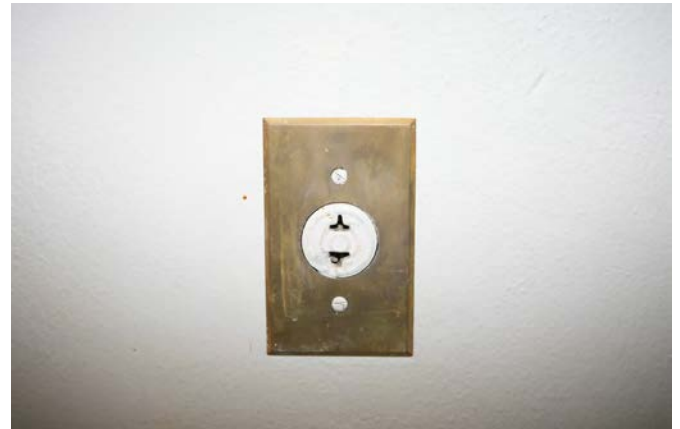
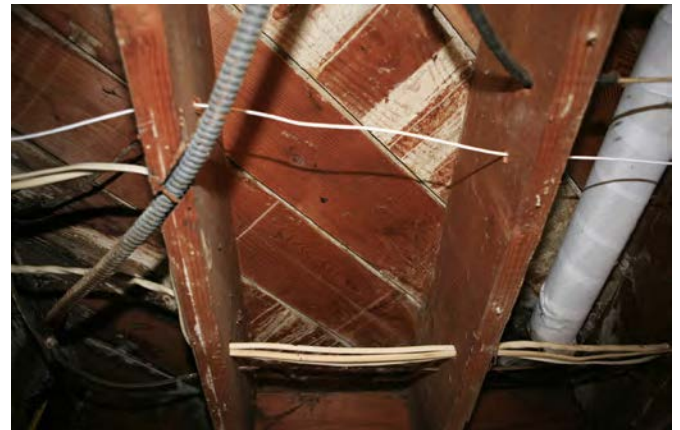
- Replacement of the majority of outlets with duplex receptacle grounded and non-grounded throughout the house. These included new cover plates.
- Replacement of the majority of switches with new and dimmer type switches throughout the house. These included new cover plates.
- Replacement of knob and tube connections to the panel by installing junction boxes in the attic.
- Electrical service (200 amp) relocated to the north wall of the northwest first floor entrance alcove. Originally electrical service enter the house at the upper north gable end.
- New electrical panel installed, this replaced a previous panel dating to the electrical service location change.

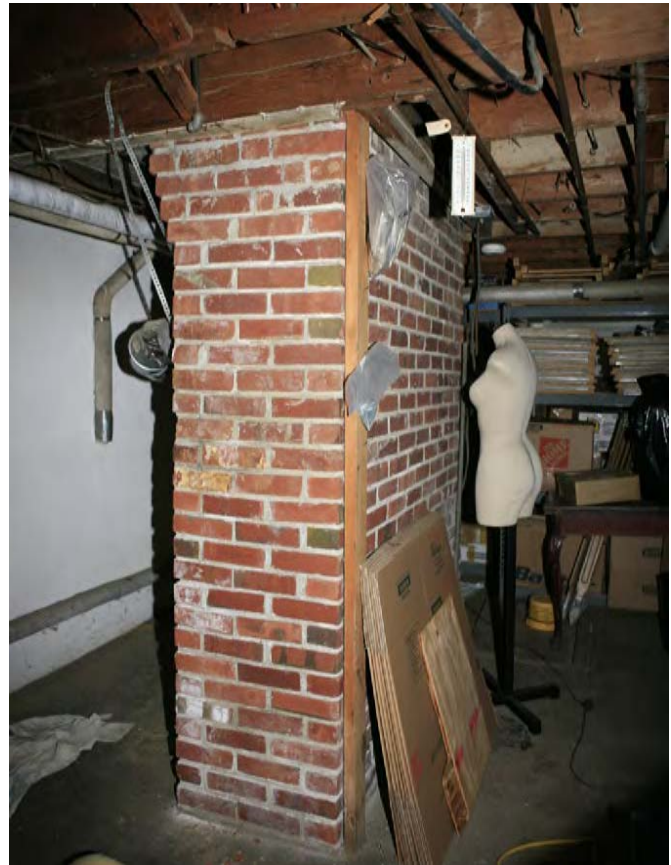
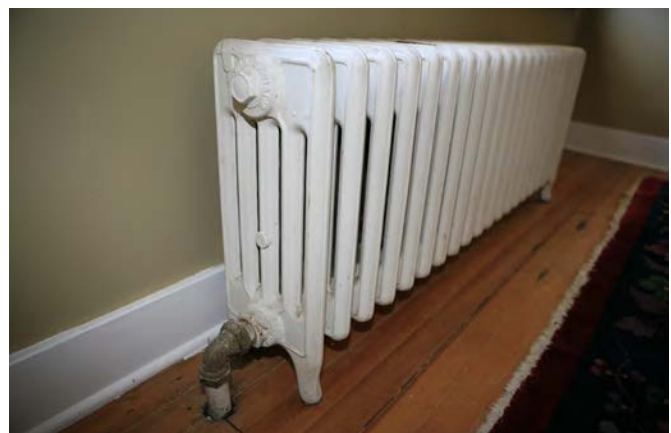
- Kitchen wood stove previously removed and a cover plate installed at the former chimney connection.
- Some minor changes on vents at individual radiator units.
- Oil tank added, No. L-821686, Axe tank and equipment company. Set up on concrete blocks. Two lines run in through the house. Added copper fuel lines through basement between this tank and the furnace.
- Oil furnace replaced with existing contemporary unit.

- Original exterior below grade oil tank (measured at approximately 500 gallons) cleaned and filled with foam in 2016. The tank is below the concrete sidewalk.

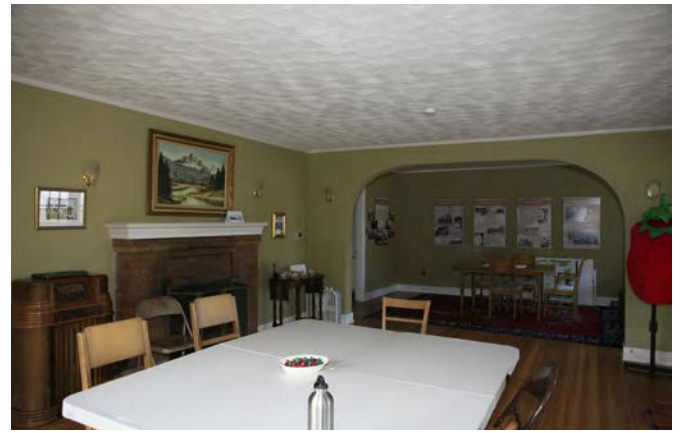
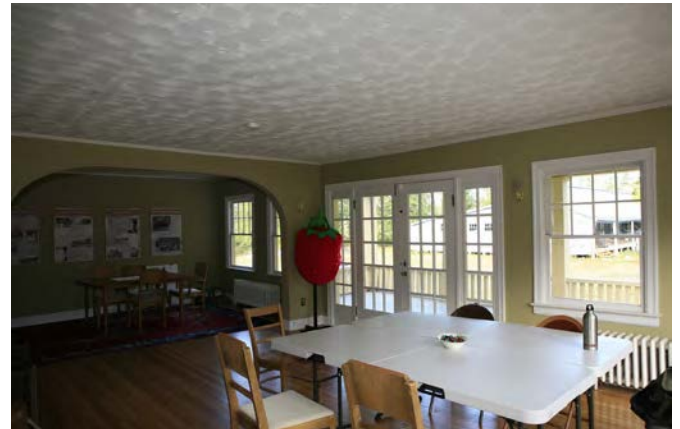
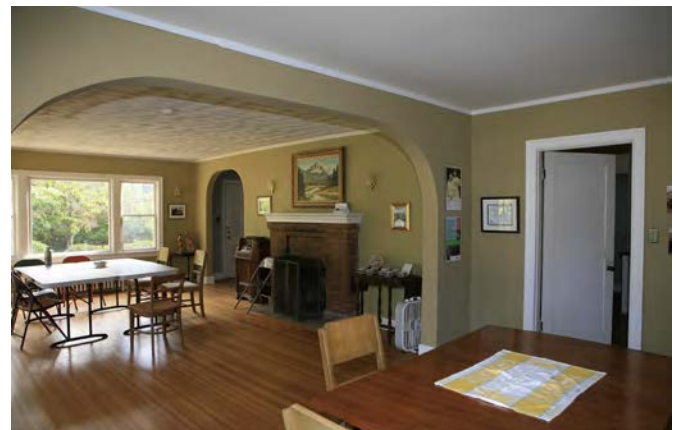
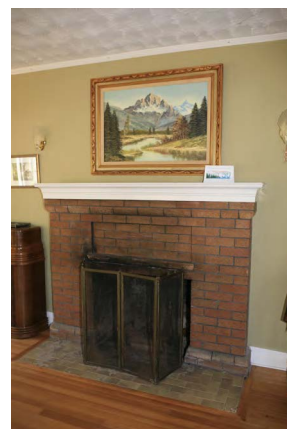
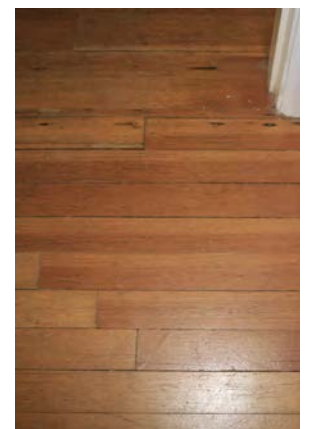
- Added scalloped finish at ceiling.
- Added wall mounted sconce light fixtures (7) with metal bases and frosted glass.
- Added ungrounded receptacles (4), locations may have been original but receptacles are later replacements.
- Grounded receptacle (1), location may have been original, but receptacle is contemporary.
- Thermostat for furnace, contemporary unit.
- Added wall switches (3), all with contemporary cover plates.

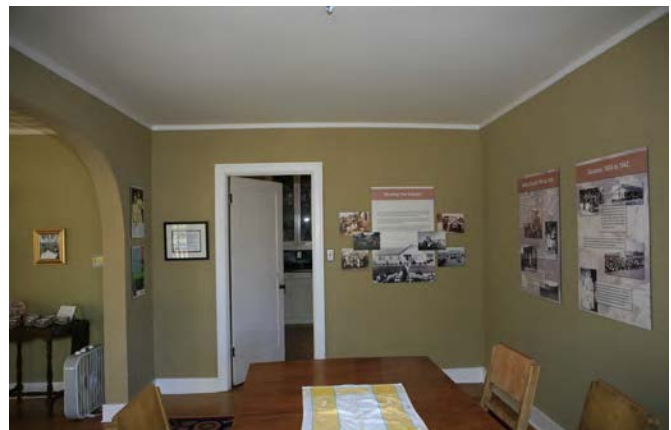
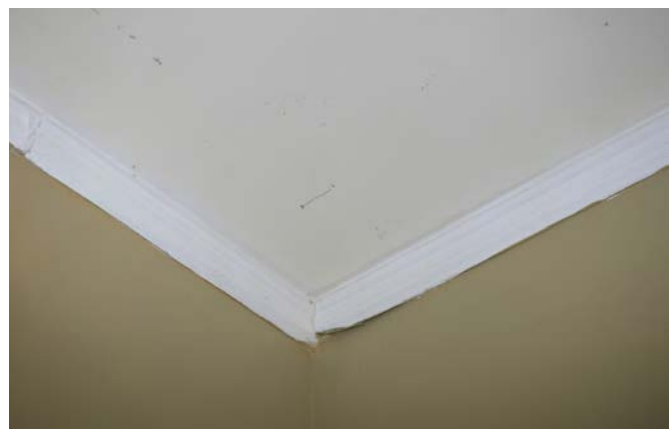
- Added portions of crown molding wraps the room. Painted, wood.
- New sheet rock ceiling added over plaster. The north portion has lost all plaster above sheet rock in outer north 2 feet likely from water damage.
- Infill of the former doorway in the west wall and addition of baseboard at this location.
- Removal of window aprons.
- Added 1 ungrounded receptacle with a contemporary cover plate.
- Added 1 new switch with a burnished plate.

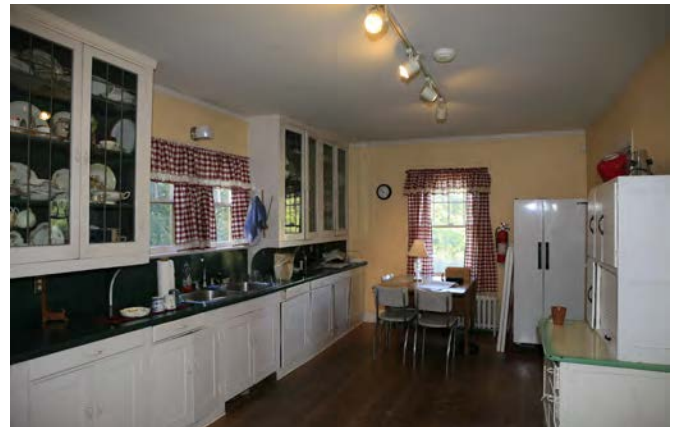
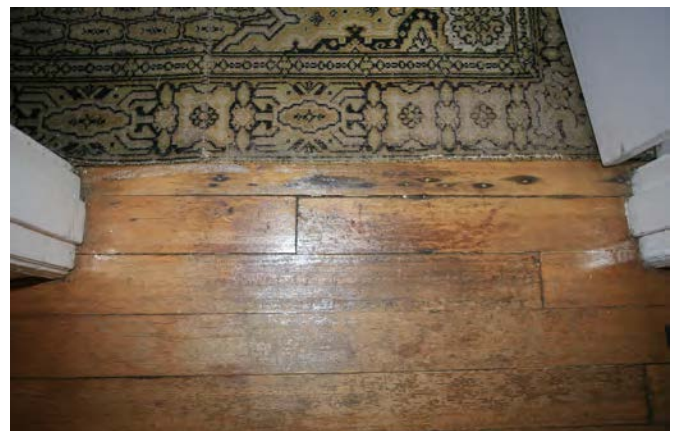
- Replacement counter is plywood.
- Apron missing on west window.
- At the lower cabinets, the three doors at the west end are later additions. These doors occur where the floor is painted.
- Due to a previous roof failure and water damage in the space, sheet rock was installed over the lath and plaster on the west, north, and east walls of the space. The entire ceiling was replaced with sheetrock. The crown molding that wraps the space is a contemporary addition. R19 fiberglass insulation installed above the ceiling.
- Added metal sink.
- Added electrical outlets (3).
- Galvanized metal pipe in the northeast corner, not known what this connected to.
- Added light switches (2).

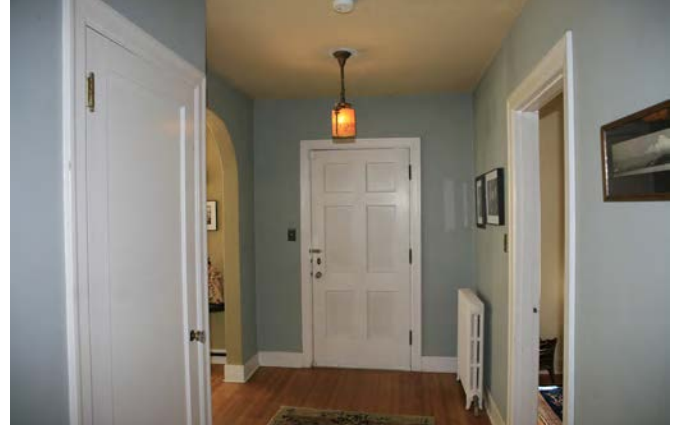
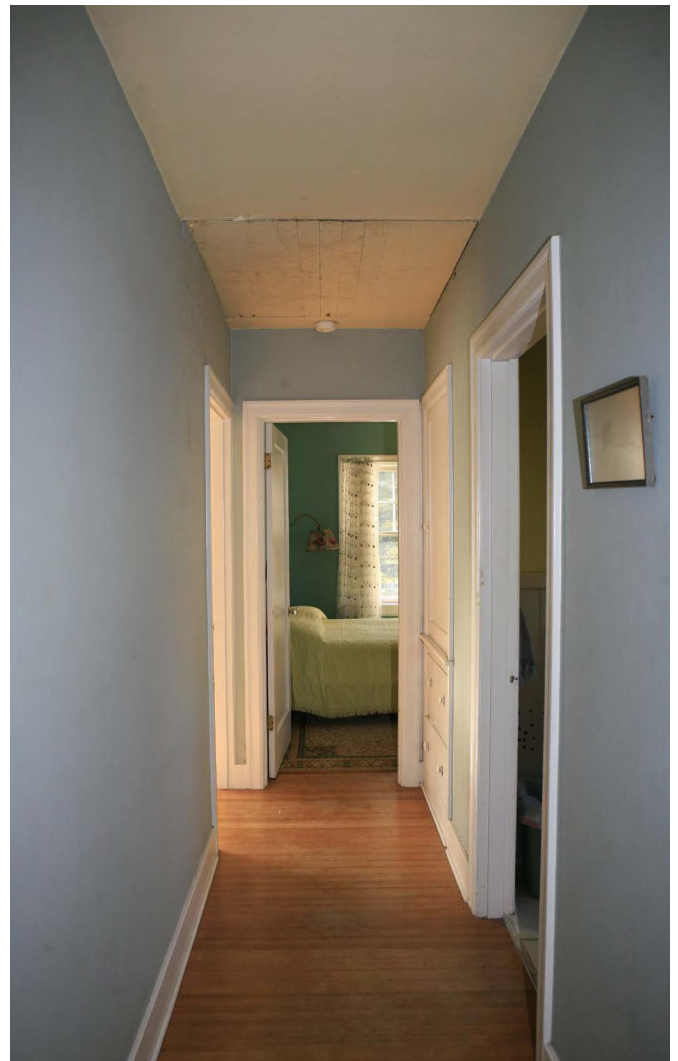
- Door bell removed from upper wall adjacent basement door wires remain.
- Repainting at north end at past water damage, with a portion of the baseboard removed.
- New light fixture at the entry vestibule at the

former original location a suspended ceiling light fixture, with a cylindrical glass shade, hand painted.

- Switch adjacent east entry door is new and new plate, switches exterior lights flanking entrance.

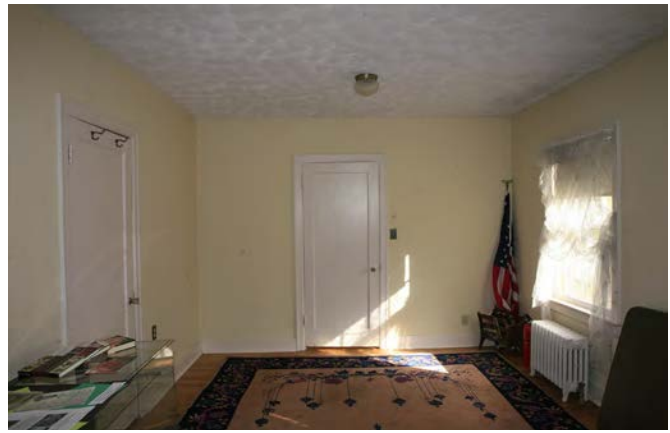
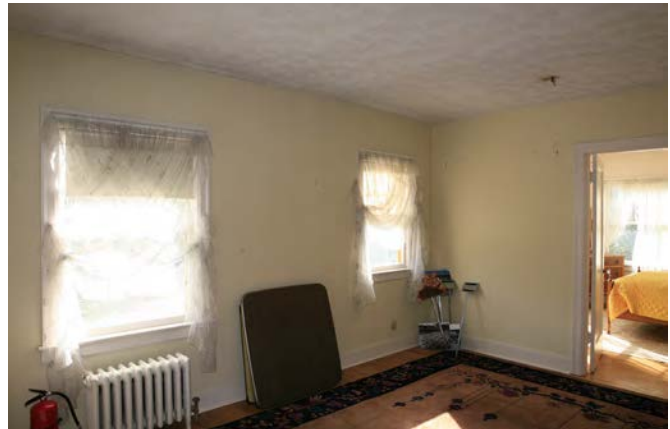
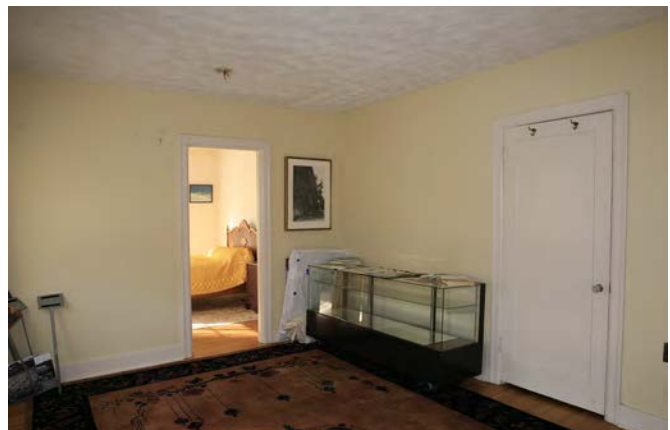
- Added decorative, scalloped plaster ceiling finish over original lath and plaster.
- Added outlets (2) with new plastic plates, duplex grounded.
- Two added ceiling fixtures with frosted glass.
- Wall switch for ceiling light at north end, contemporary, burnished metal plate.
- Phone data connect box on baseboard.

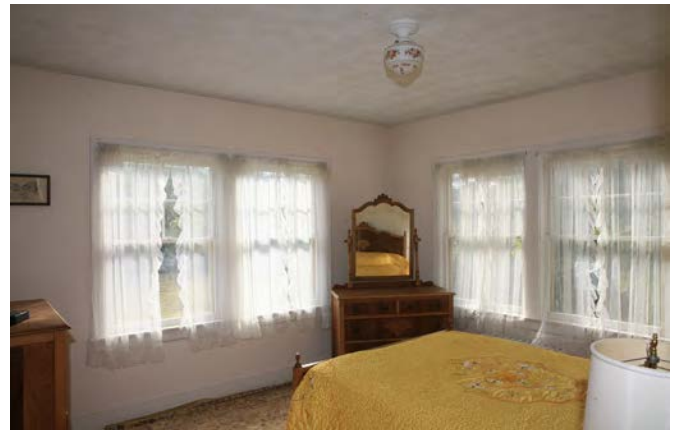
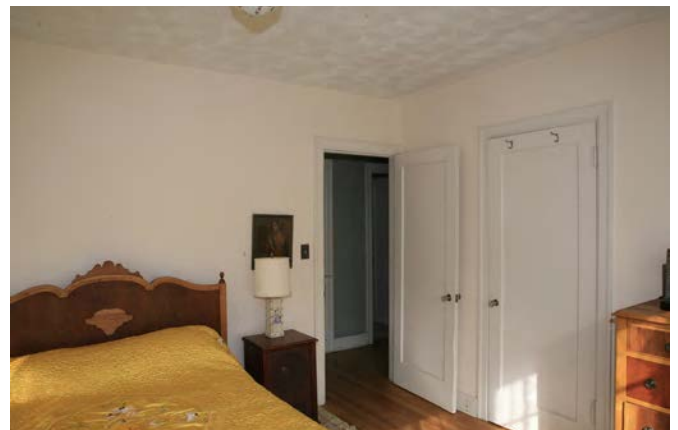
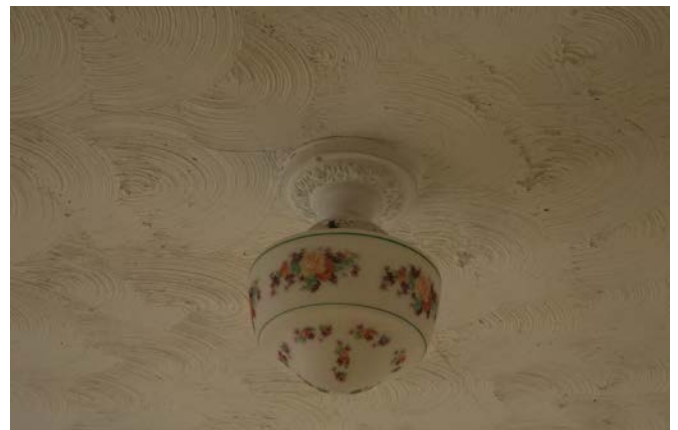
- Scallop ceiling added after light fixture installed. If done originally would have kept fixture off and the installed. Can clearly see in this room with plaster overlap onto fixture sides.
- Radiator: supply pipe through wood but no cover escutcheon at return same issue.
- Switch: 1 new (overhead fixture).
- Outlets: (1) metal cover plate, burnished finish, duplex grounded, on north wall and (1) metal cover plate, duplex ungrounded, metal plate.

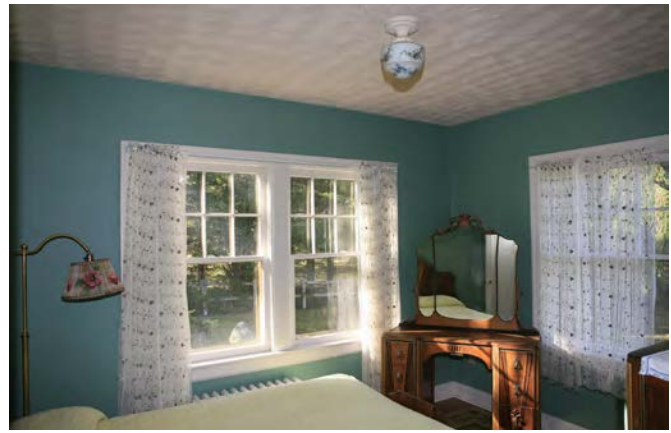
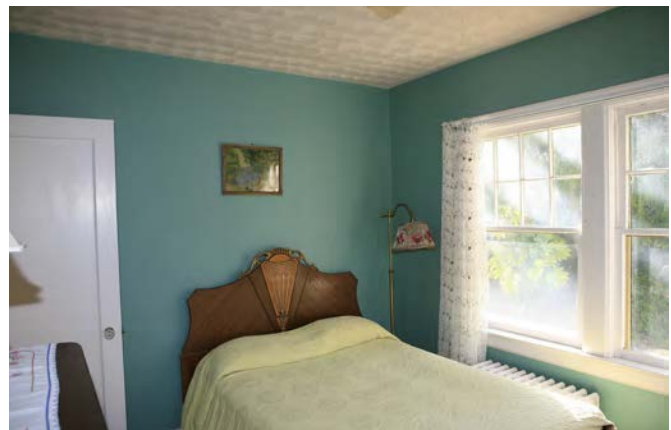
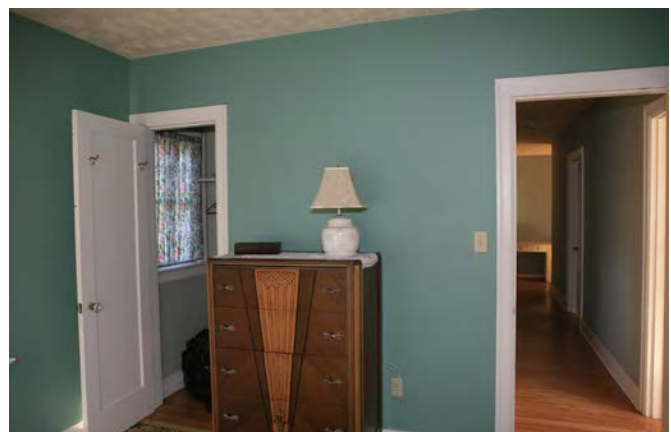
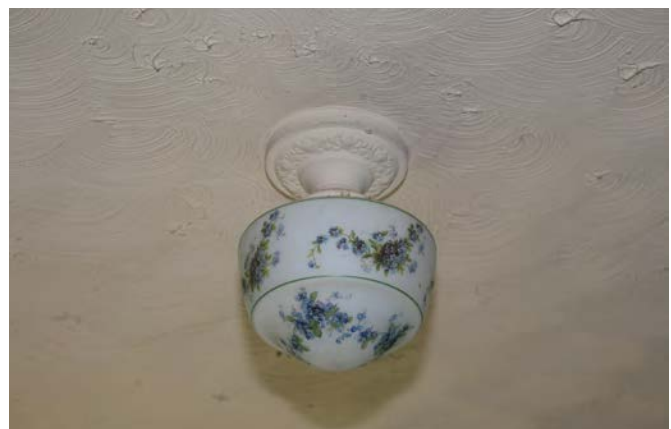
- Closet: added metal brackets along north side and associated shelf. Plumbing access cut out in north wall and patched with sheet rock. Interior escutcheon missing in closet door.
- Damage to plaster from door knob impact.
- Some markings in floor from furniture, dresser has small wood wheels that can scratch floor
- Outlets: duplex, grounded, new (3) bottom of lower receptacle 14-1/2 inches above floor.
- Switches: 1 new (overhead fixture).

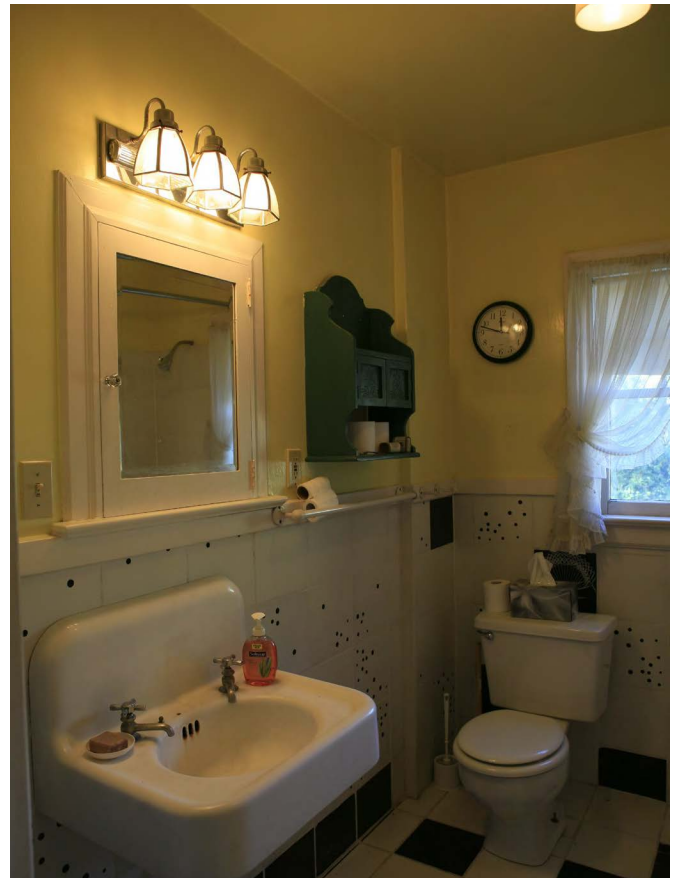
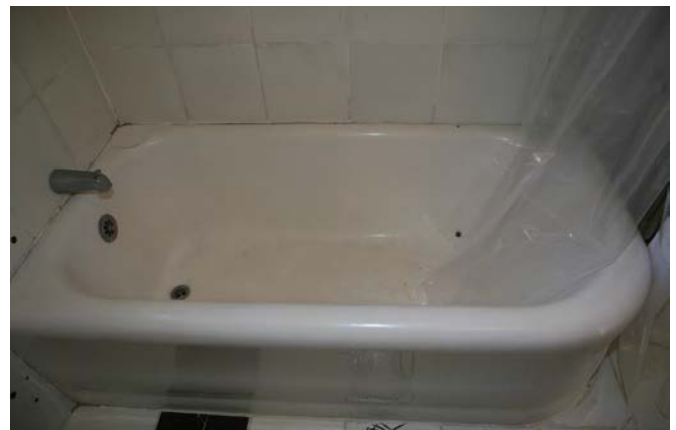
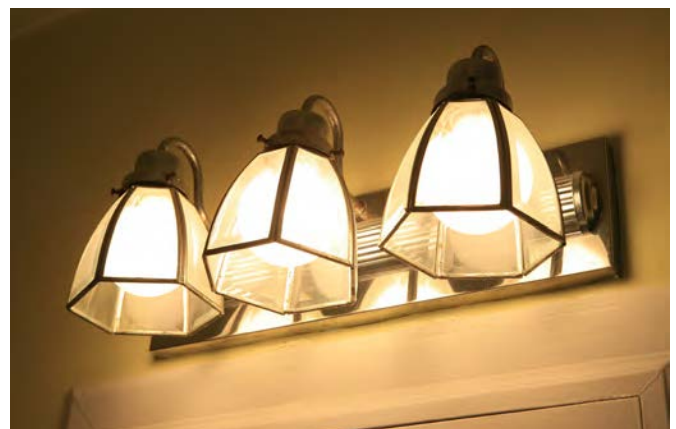
- Contemporary tile floor and tile wainscot.
- Added hooks mounted to wainscot cap.
- Added wood cap at tile wainscot wood trim.
- Contemporary toilet.
- Ring type towel holder.
- Switch (3) contemporary, switch by doorway appears original, had to cut wood wainscot cap when added tile wainscot and cap.
- Outlets (1) GFI added.

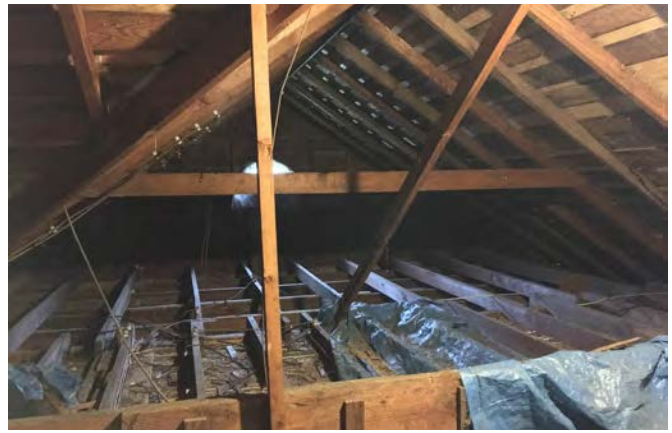
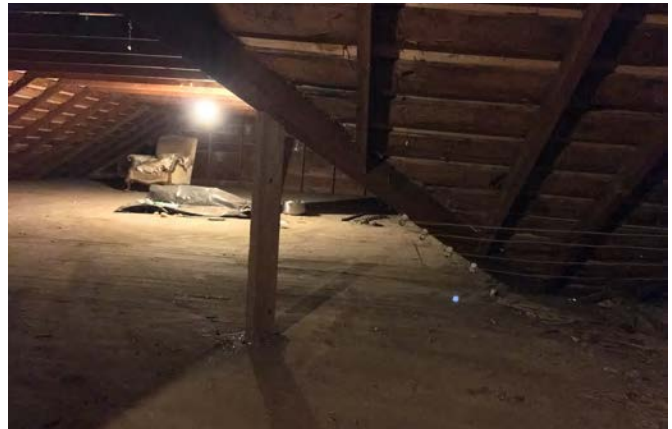
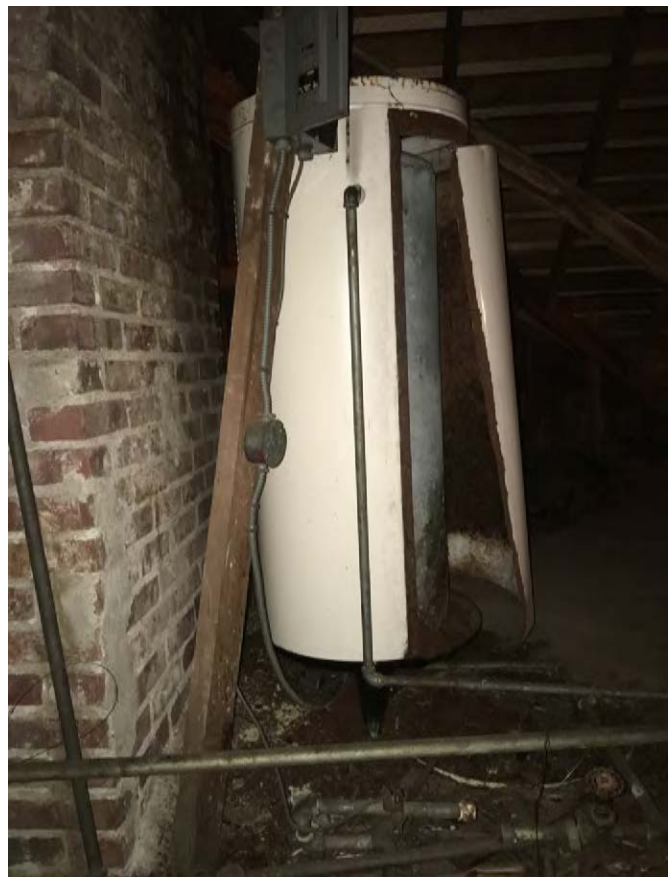
- Ridge vent with building wrap cover installed as part of reroofing the building in 2016.
- Plywood sheathing installed as part of the 2016 reroofing.
- Fiberglass insulation (R19) added over the kitchen between the joists.
- White water tank and associated piping south of the chimney.
- Light fixtures added in the south and north end to provide illumination.

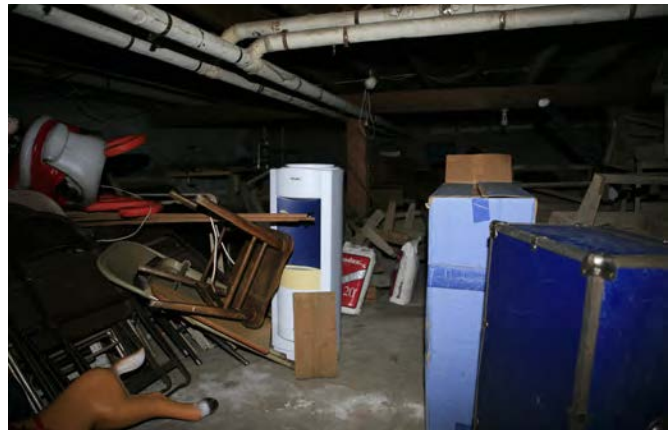
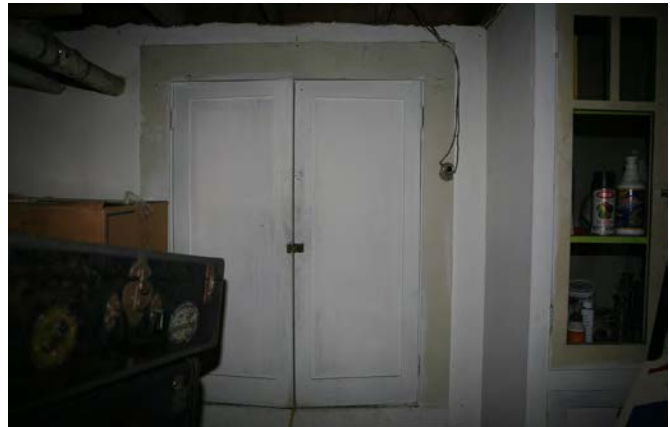
- Patch at lower west corner of north opening in the concrete.
- Void in southeast corner 6 by 7-inch with soil exposed. Thin slab just 1/2 thick at this location.
- Water entry at footing level along south side.

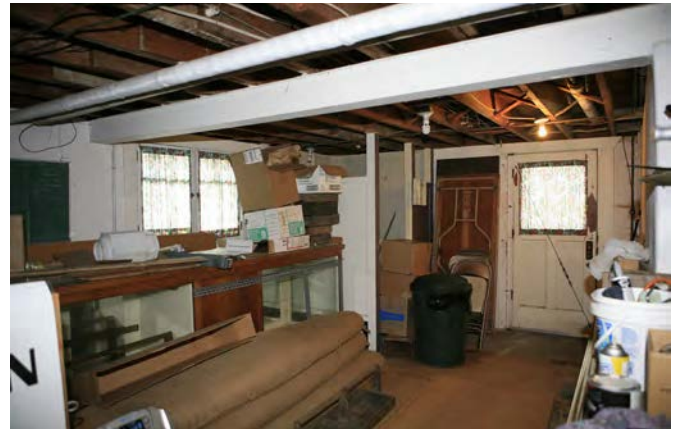
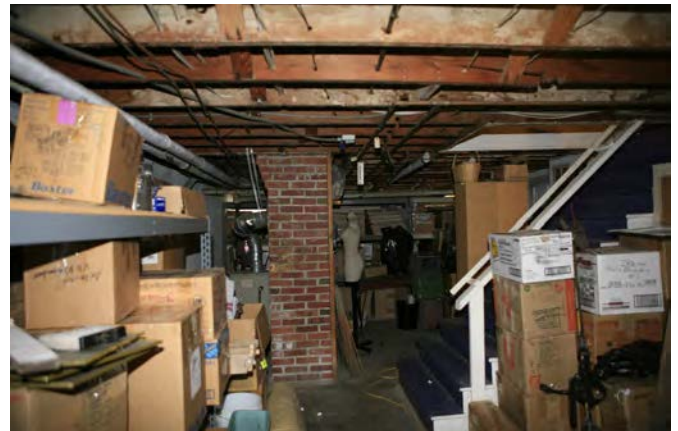
- Trench added, 18-inches wide along the basement from the north door, runs south and T's at the door with branch running to the west basement door and the drain in the base of that door. The other runs east.
- Water heater adjacent utility sink.

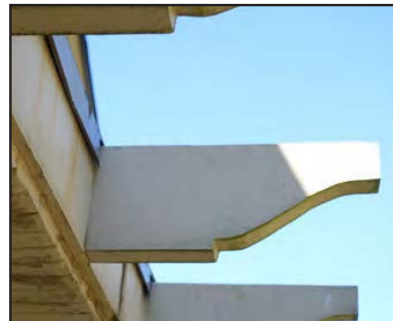
MHW-DET 1

Location: Mukai House
Elevation: West
Detail: Fascia

- Substrate: wood
1. Thick, smooth (BM OC-69 White Opulence)
 2. Thin, smooth (BM 178 Golden Lab)

Note: Lack of paint layers is surprising, although may be explained by the sheltered nature of the sample location. Other explanations are in-kind replacement or multiple, indistinguishable layers of white paint.

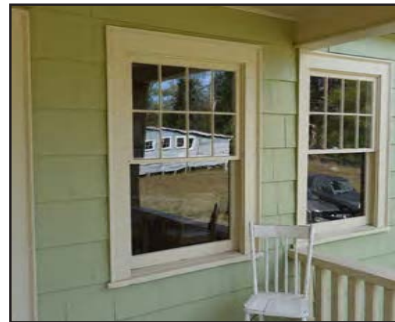
MHWC1

Location: Mukai House
Elevation: West
Detail: Window casing/trim

1. thin, uneven layer (BM 178 Golden Lab)
2. thin, uneven layer (BM OC-108 Pale Moon)
3. smooth (BM 1610 French Beret)
4. thin, smooth (BM OC-46 Halo)
5. thin, several voids (BM OC-48 Hazy Skies)
6. smooth layer of paint or primer (BM OC-69 White Opulence)
7. thick, smooth (BM 331 Lemon Souffle)

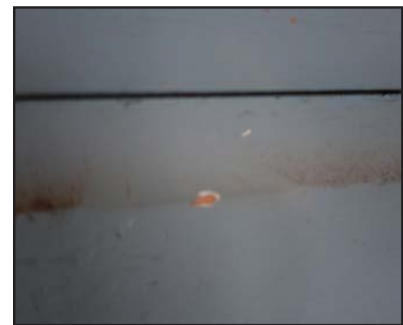
SHED-S

Location: Mukai Shed Exterior
Elevation: South
Detail: Siding fragment

Substrate: wood (not visible in sample image)
1. thin, partial layer (BM 977 Brandon Beige)
2. very thick (BM 1593 Adagio)

Note: Unable to collect viable sample from Shed windows while on site due to a lack of existing paint.

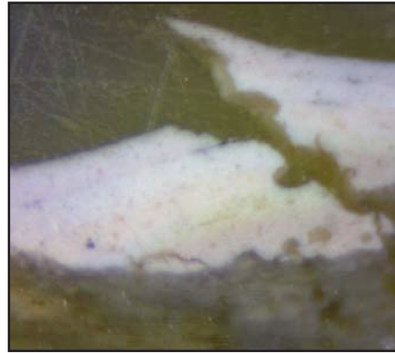
MHI9E1

Location: Mukai House Interior
Room: 9
Detail: wall elevation

1. smooth, BM 282 (Counting Stars)
2. smooth, BM 143 (Golden Light)
3. thin, very smooth, BM OC-70 (Whitewater Bay)
----(dirt layer)----
4. smooth, uniform, BM OC-81 (Evening White)

Note: Original layer is a stained plaster.

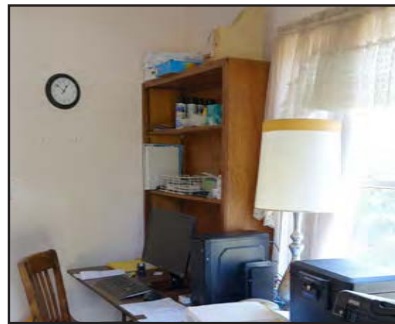
MHI9D1

Location: Mukai House Interior
Room: 9
Detail: door

1. thin, smooth (BM OC-69 White Opulence)
2. thick, smooth (BM OC-105 Calming Cream)

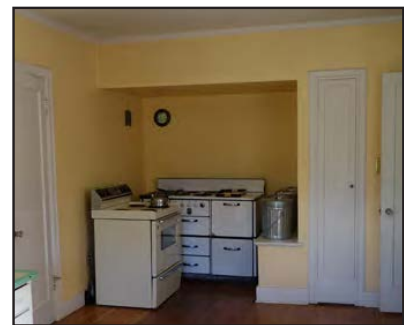
MHI8_DET1

Location: Mukai House Interior

1. thin, flaky, shiny wood varnish
2. Thin, smooth layer (BM OC-69 White Opulence)

Note: Although difficult to capture in the sample image, it's clear the original finish was a brown, non-opaque, wood varnish. The sample was taken from existing splits in the cabinet wood.

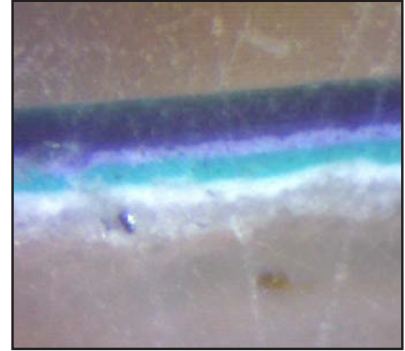
Note: The backsplash is a manufactured wood veneer product tacked to the wall. There's no way to know from the sample if it is original to the kitchen, or installed at a later date.

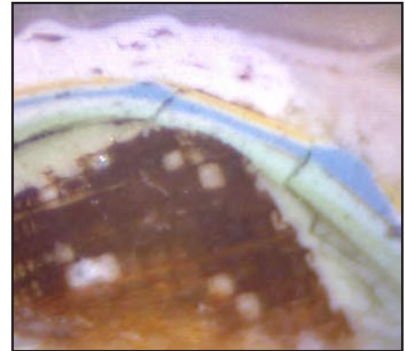
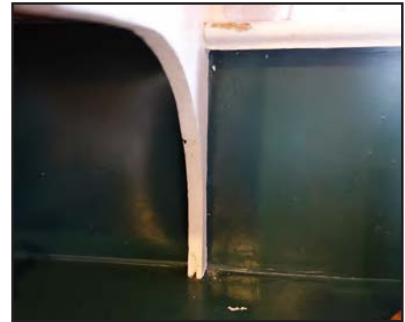
MHI8D4B

Note: The built-in ironing board cabinet in the kitchen had a similar chronology, with the "Garland Green" color still intact on the interior.

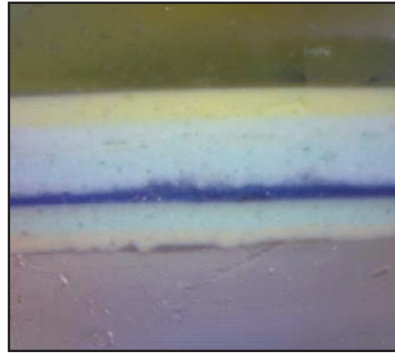
Note: Substrate is a tinted plaster

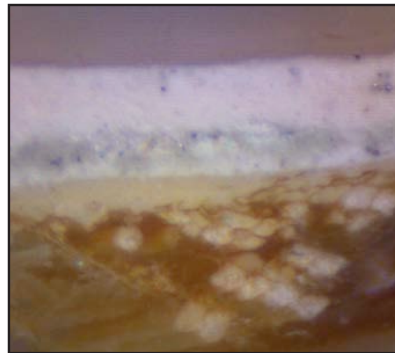
Note: This sample was taken from the wall trim at chest height. The number of layers do not match other layers taken from the medicine cabinet, door or window indicating it was installed at a later time, although still relatively early.

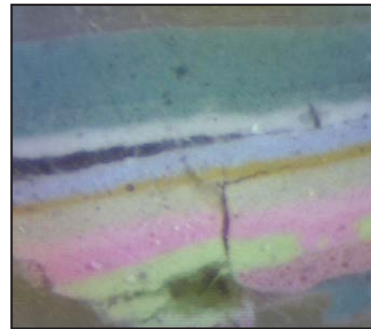
Note: The original layer is a tinted plaster similar to what was used in rooms 4 and 5. The lime green and pink color scheme is wild! I've never seen anything like it.

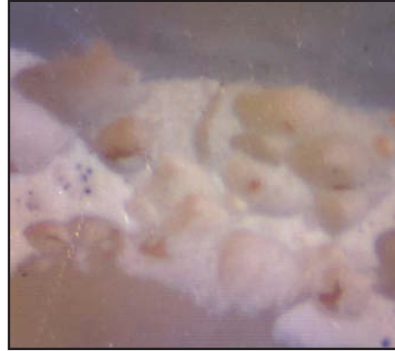
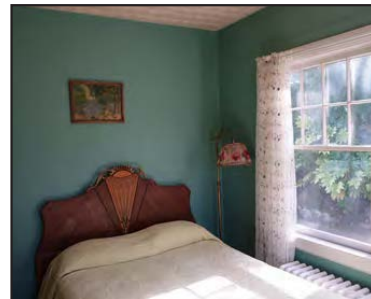
MHI6C1

Note: The ceiling is a tinted, decorative plaster finish in the original color.

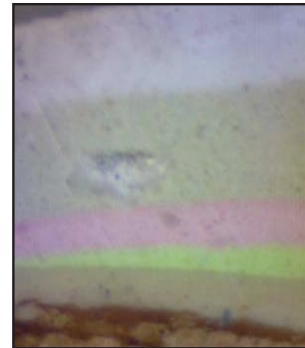
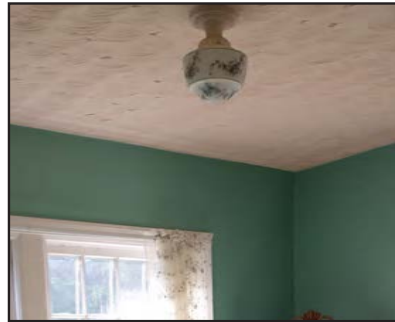
MHI6D12

Note: I was surprised to see the lime green, pink, and taupe color repeated in the door chromochronology. Also strange was the duplicative taupe color in the fourth layer that was virtually identical to the first layer.

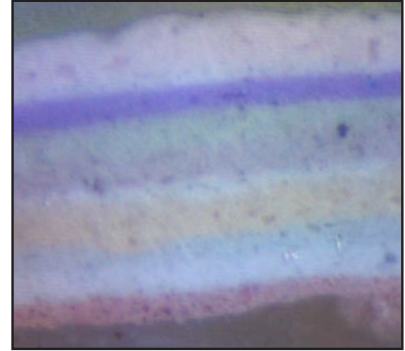
Note: Original layer is tinted plaster similar to what was used in rooms 4 and 6.

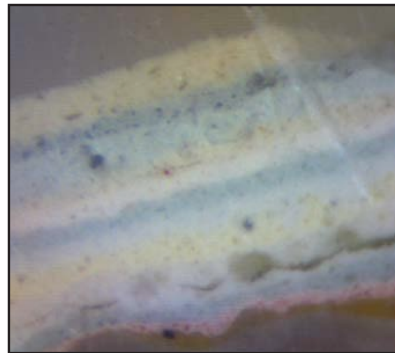
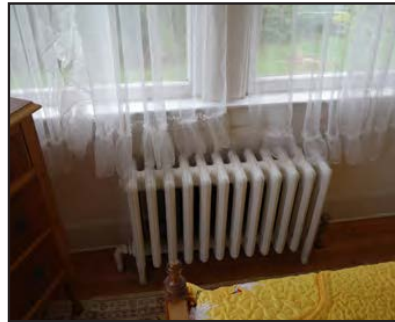
MHI4E1

Note: Original layer is tinted plaster similar to what was used in rooms 5 and 6.

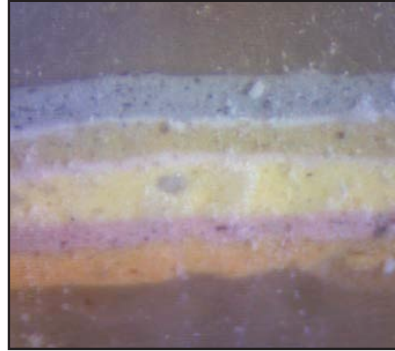
Note: Original layer is a tinted plaster.

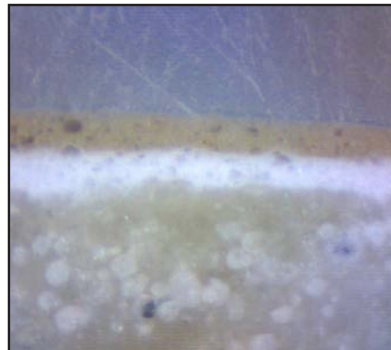
Note: plaster substrate is white.

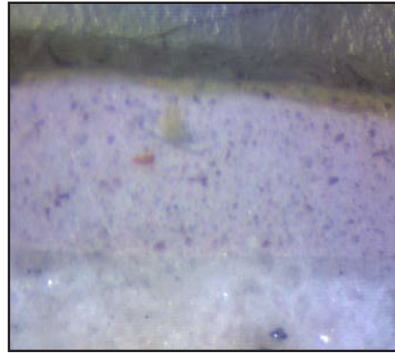
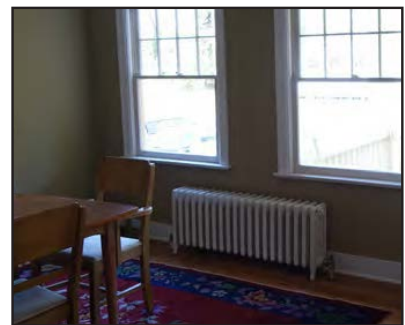
MHI1E1

Note: Original layer is a tinted plaster.

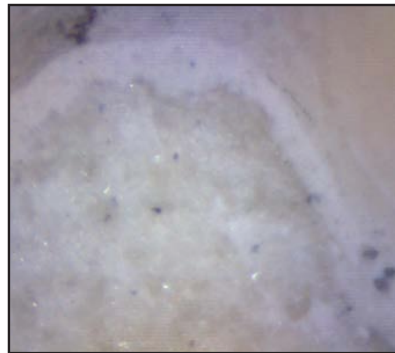
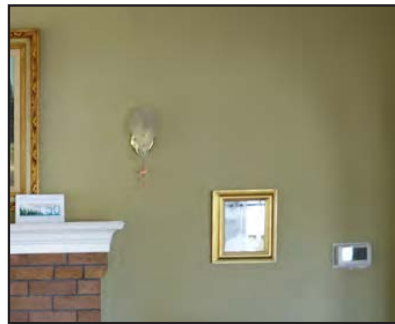
MHI1C1

Note: Ceiling is a textured plaster.
