Mukai

Farmstead and Garden

PRESERVATION PLAN

April 2017

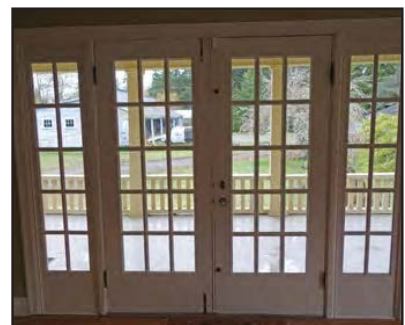
MHI1W1

1. uneven (BM 1039 Stone House)
2. thin, smooth (BM 254 Woven Jacquard)
3. thin, smooth (BM OC-112 Goldtone)
4. thin, smooth (BM 254 Woven Jacquard)
5. very thin (BM OC-105 Calming Cream)

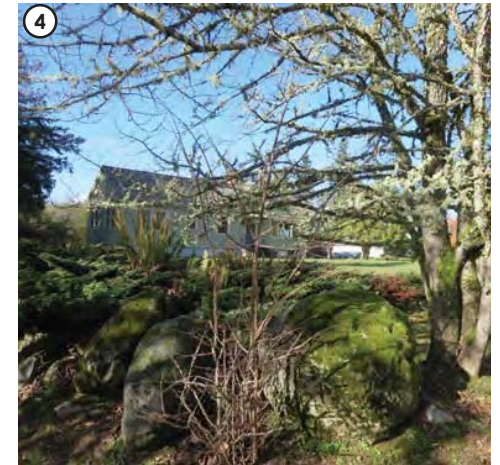
4 The rockery wall along the upper lawn's east side, with elm obscuring view. (11/16, KKLA)

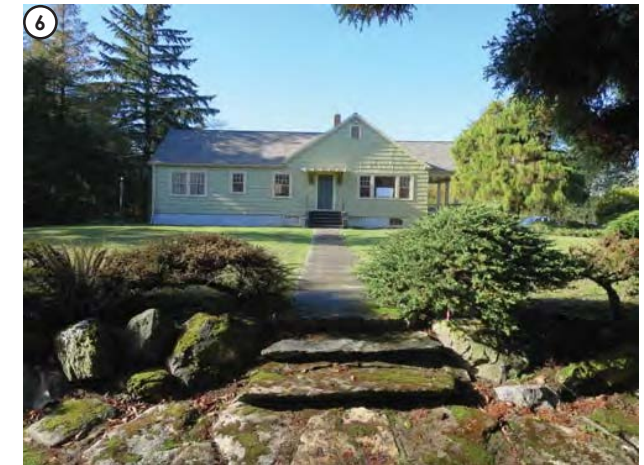
6 Stone slabs still serve as steps, concrete walk beyond. No plantings at house remain. (11/16, KKLA)

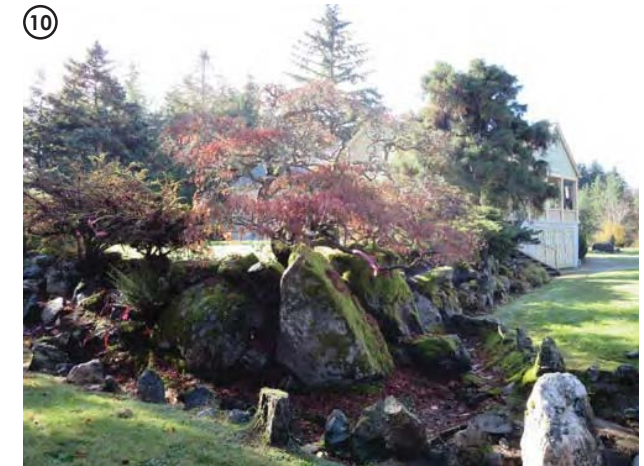
10 Rockery with sole remaining Japanese Maple at corner. (11/16, KKLA)

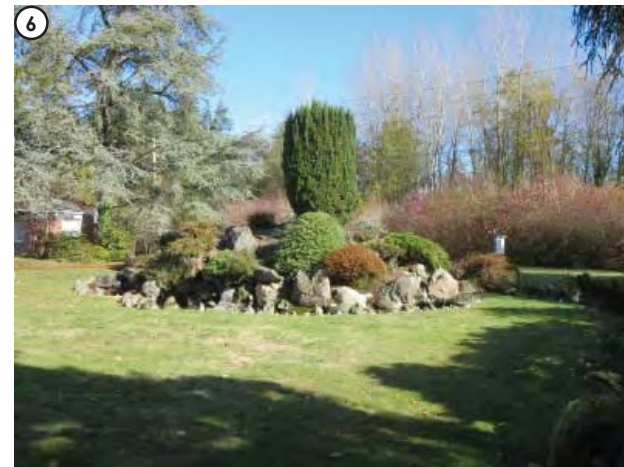
6 Looking northeast at the north island and lower lawn, with Yew only remaining tree on island, with few cherry trees in the background. (11/16, KKLA)
